# Diagnosis report of 2017 PEUGEOT 3008 Allure

# Preparation and repair report of 2017 PEUGEOT 3008 Allure

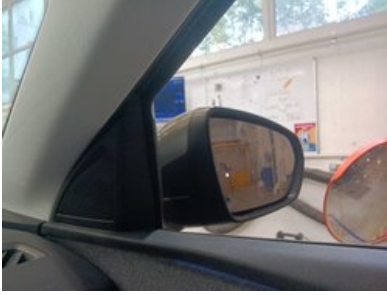
- ✓ **1. Doors:** Exterior Side Mirrors - Electronic Controls, Folding, and Adjustment

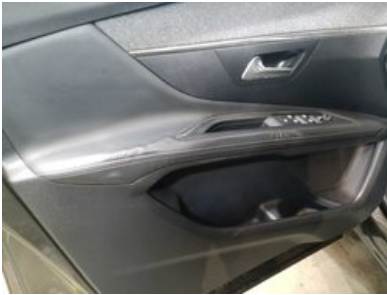
- 
- ✓ **2. Doors:** Trims - Condition

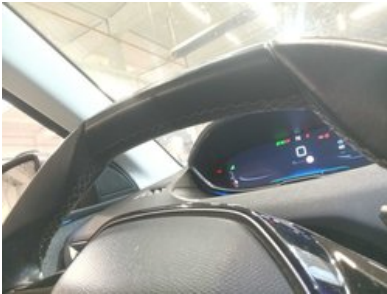
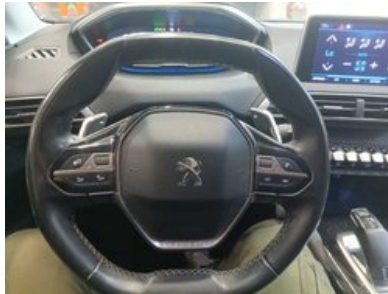
- 
- ✓ **3. Front:** Steering Wheel - Condition

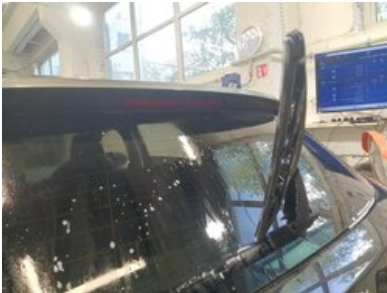
- 
- ✓ **4. Front:** Window Wiper Rubber and Handle (Front and Rear) - Condition

- ✓ 1. Spark Plugs
- ✓ 2. Change Rear Wiper (Mechanical)
- ✓ 3. Engine Oil & Filter Change

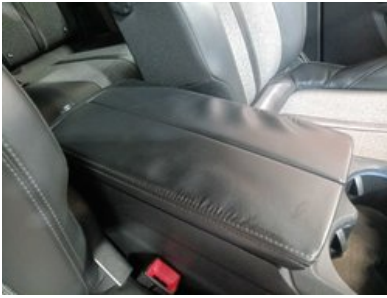
✓ **5. Inside:** Armrest - Operation and Condition

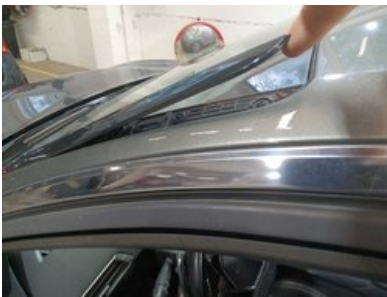
✓ **1. Front:** Windscreen Integrity - Free from MOT-Excluding Damage

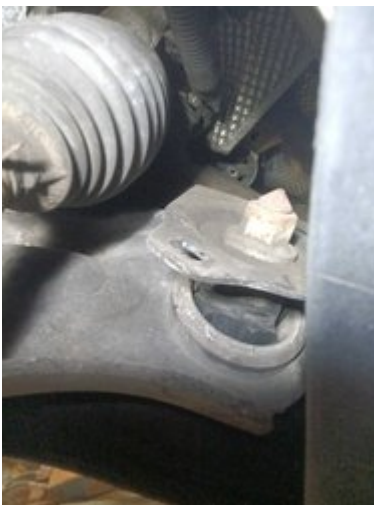
✓ **3. SUSPENSION:** Suspension Lower Arm Bushes
