# Diagnosis report of 2021 PEUGEOT 2008 GT

During the comprehensive diagnosis conducted by Longo, 12 issues were identified in the vehicle.

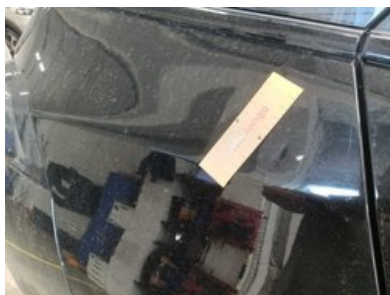
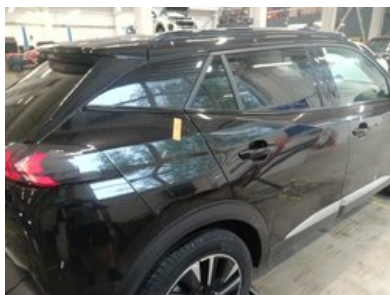
### ✓ 1. Side: Left and Right Side - Visual Damage and Scratches

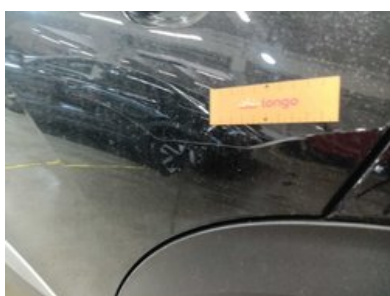
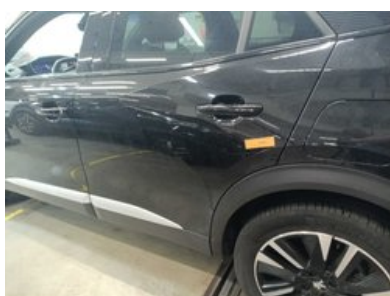
### ✓ 2. Side: Left and Right Side - Visual Damage and Scratches

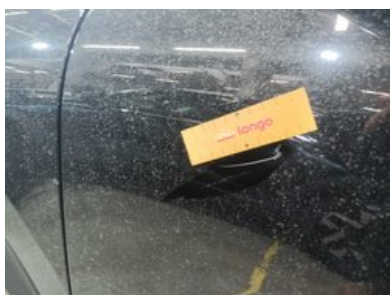
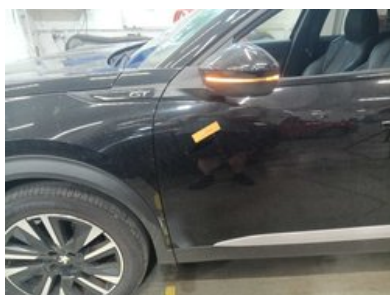
### ✓ 3. Side: Left and Right Side - Visual Damage and Scratches

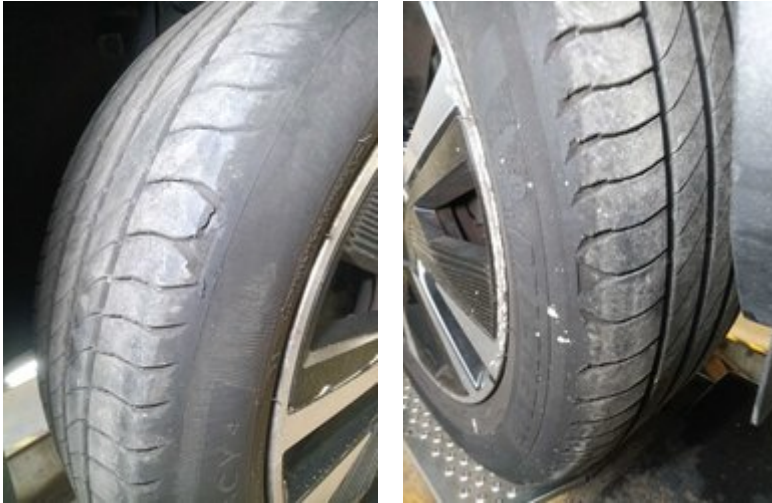
✓ **3. OTHER:** Change Tires

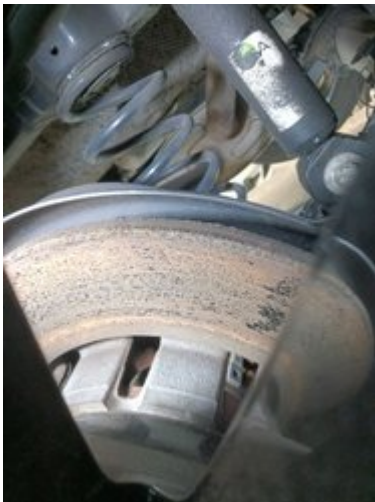
✓ **5. BRAKES:** Rear Brake Disc (Both)

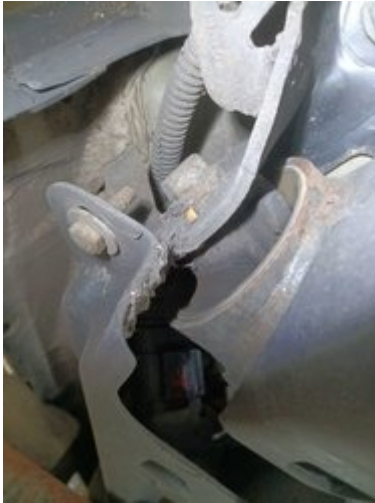
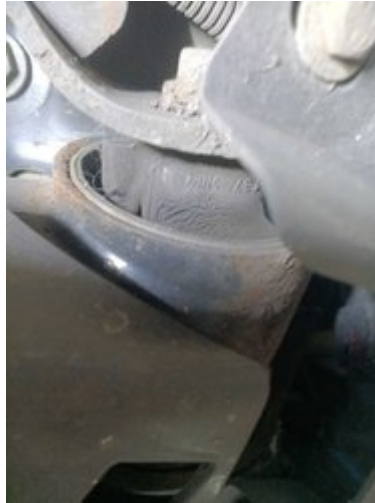
✓ **6. FINAL DRIVE, SHAFT & AXLES:** Bridge Silent Blocks
