# Diagnosis report of 2021 TOYOTA COROLLA Business Plus

| VIN Code: SB1Z93BE80E157001 | Fuel consumption: 3.80 l/100km |

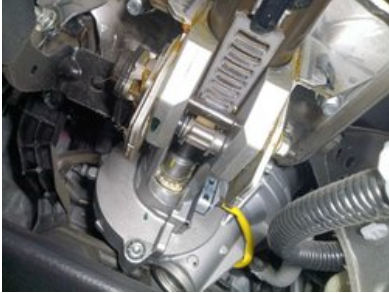
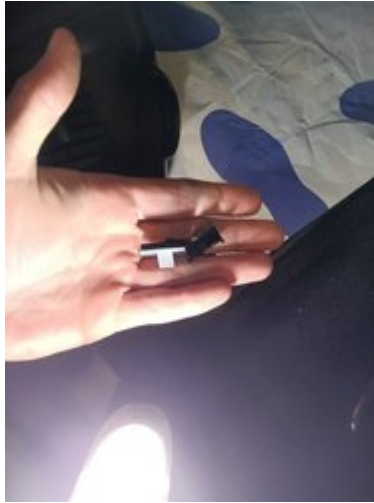
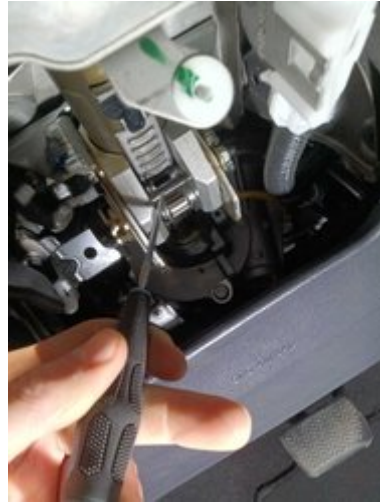
- ✓ **1. Front:** Steering Wheel - Condition

- ✓ 1. Other: Repair Steering Wheel Adjustment

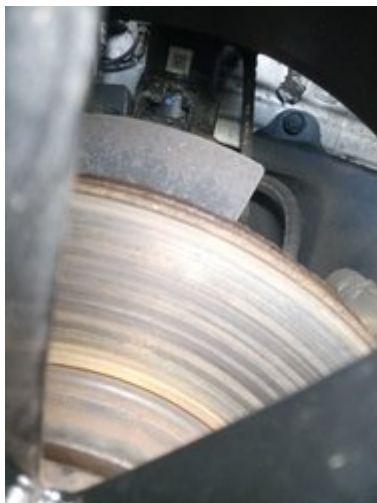
✓ **2. BRAKES:** Front Brake Discs Both

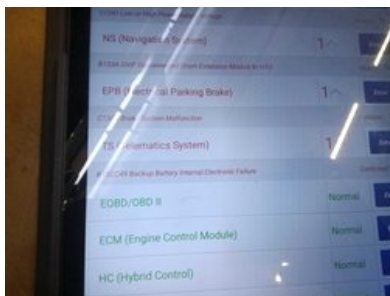
✓ **3. GENERAL ELECTRICS:** Backup Battery
