# Diagnosis report of 2019 OPEL CROSSLAND X 120 Year Editi

Checked by Longo Shared Service certified diagnostics team: Eimantas A., Arnas S.

During the comprehensive diagnosis conducted by Longo, 5 issues were identified in the vehicle.

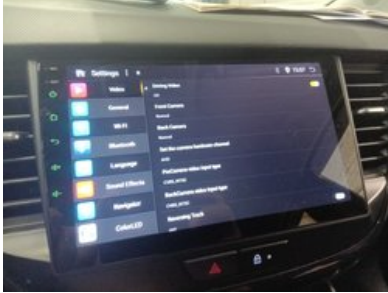
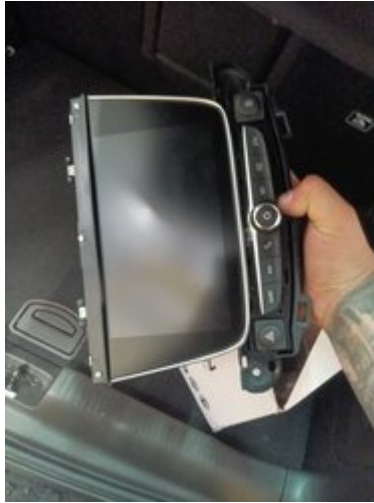
### ✓ 1. Operation: Navigation and Radio System - Operation

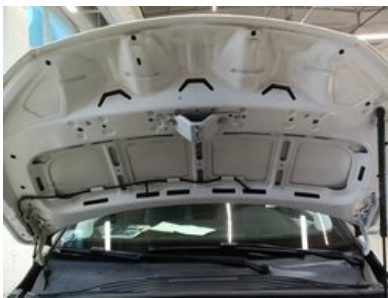
### ✓ 1. Front: Hood Sound Insulation - Condition

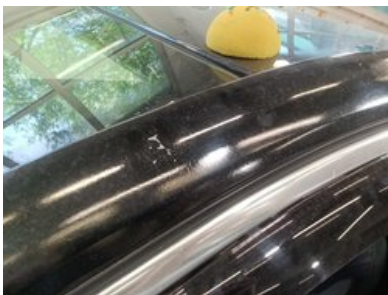
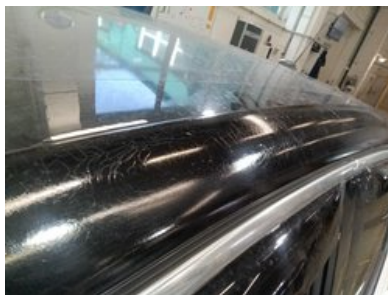
### ✓ 2. Side: Left and Right Side - Visual Damage and Scratches

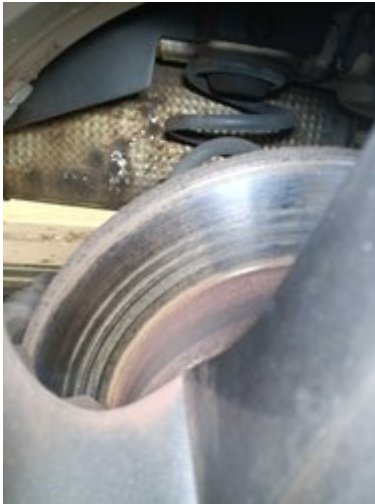
✓ **2. BRAKES:** Rear Brake Disc (Both)

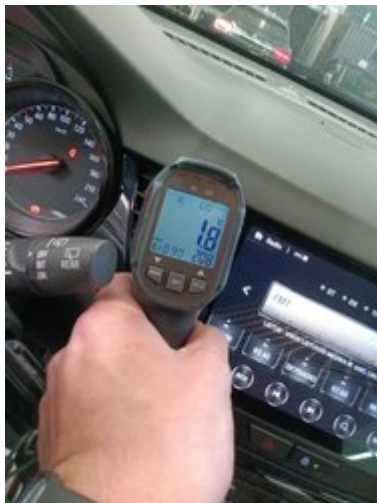
✓ 4. Air-Conditioning Measurement

- ✓ 1. System Evacuation/Recharging
