# Diagnosis report of 2014 HONDA CIVIC Sport Business Editic

Diagnosis report of

2014 HONDA CIVIC Sport Business Editic

# Preparation and repair report of 2014 HONDA CIVIC Sport Business Editic

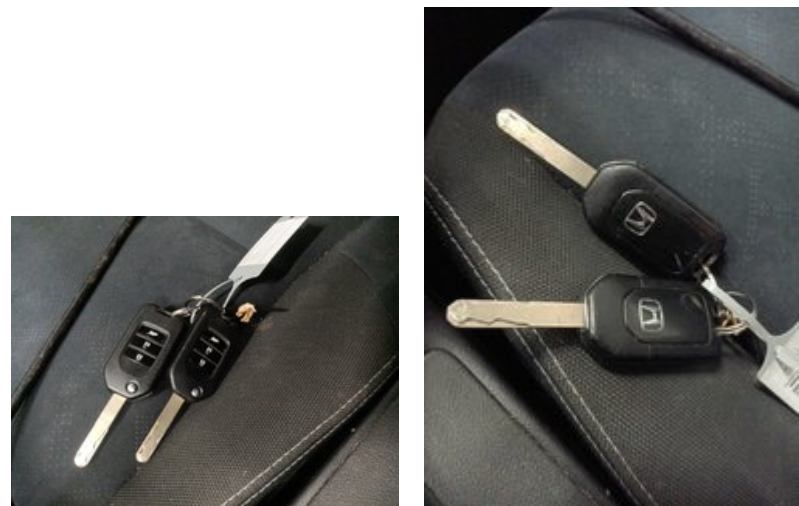
- ✔ 1. Inside: Accessories - Functioning and Condition

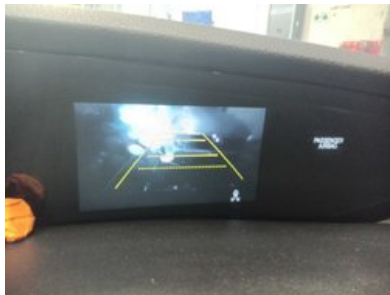
✓ **2. Inside:** Accessories - Functioning and Condition

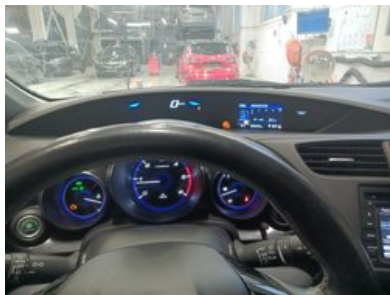
✓ **3. Inside:** Accessories - Functioning and Condition

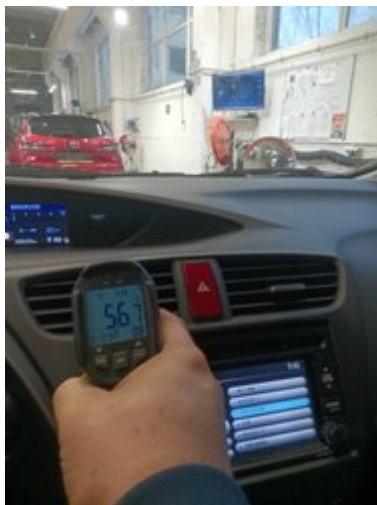
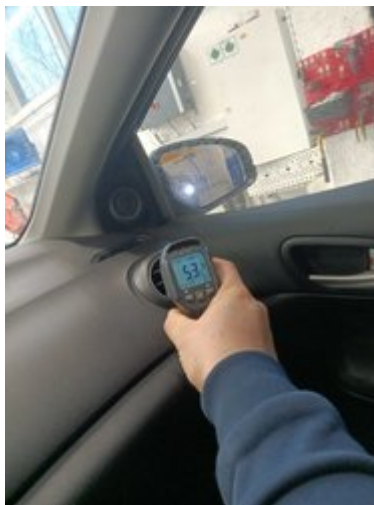
✓ **4. Inside:** Accessories - Functioning and Condition

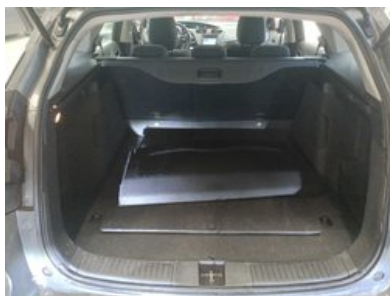
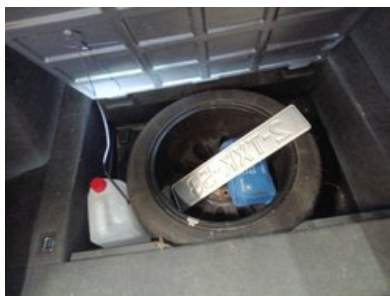
✓ **5. Inside:** Accessories - Functioning and Condition

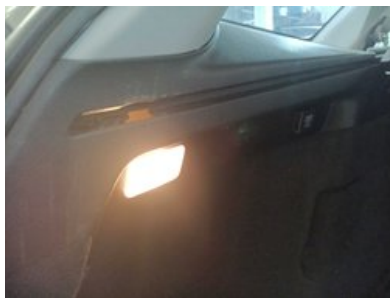
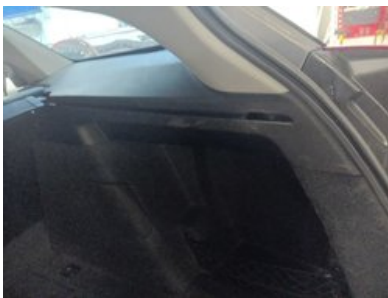
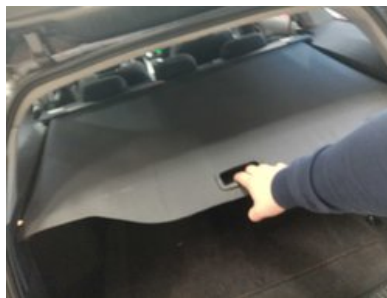
✔ **6. Inside:** Parcel Shelf - Operation and Condition

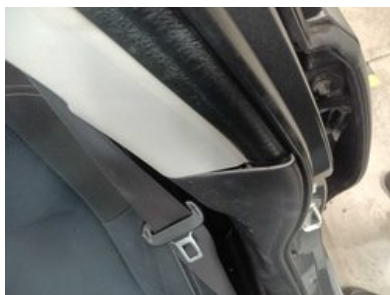
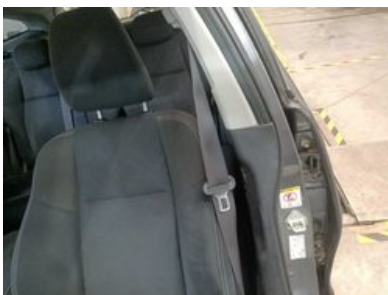
✔ **7. Inside:** Trims - Condition

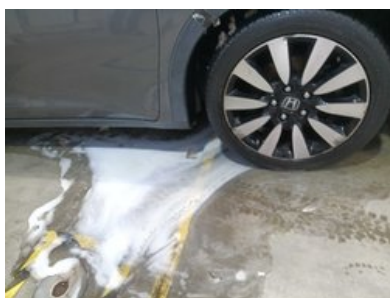
✔ **8. Front:** Window Wash System - Functioning (Front and Rear)

- ✓ 1. Fender Plastic
- ✓ 2. Repair Washer Mechanism
- ✓ 3. Change Hood Holding Mechanism

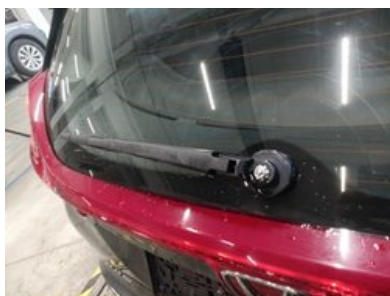
✔ **9. Front:** Window Wiper Rubber and Handle (Front and Rear) - Condition

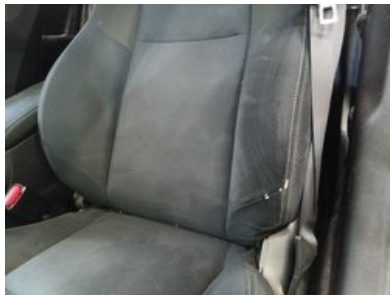
✓ **10. Seats:** All Seats - Condition

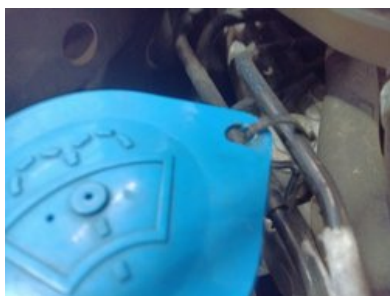
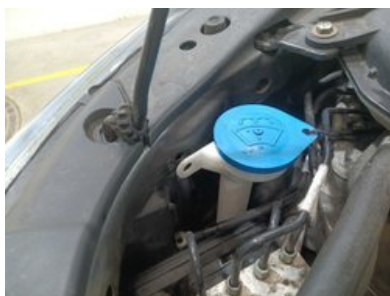
✓ **1. Front:** Window Washer Fluid Level (In Winter Also Winter-Adequate Fluid)

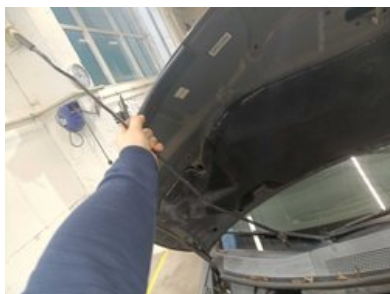
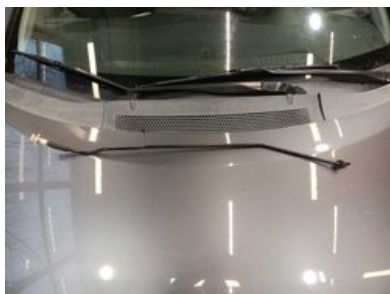
✓ **2. Front:** Hood Opening and Holding Mechanism

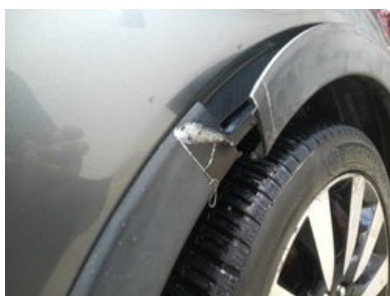
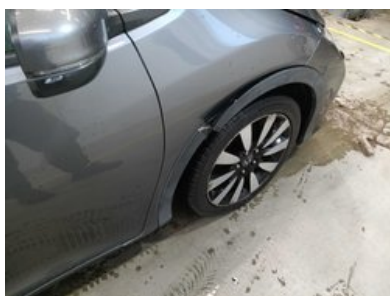
✓ **3. Side:** Left and Right Side - Visual Damage and Scratches

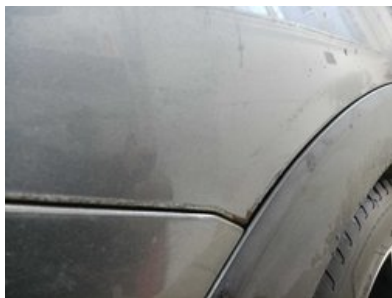
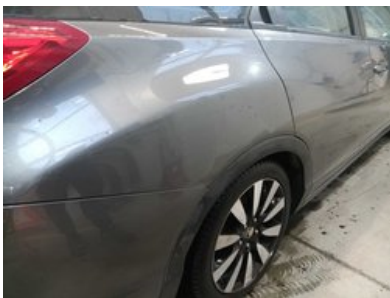
✓ **4. Side:** Left and Right Side - Visual Damage and Scratches

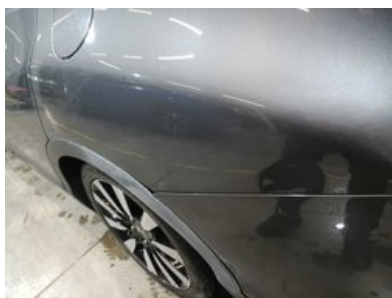
✓ **5. Side:** Left and Right Side - Visual Damage and Scratches

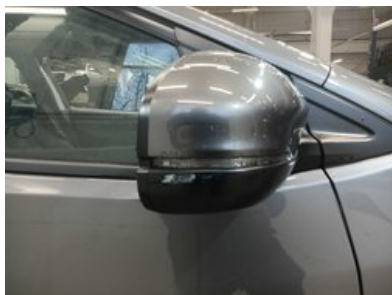
✓ **6. Side:** Exterior Mirrors - Mirror Integrity and Car Attachment

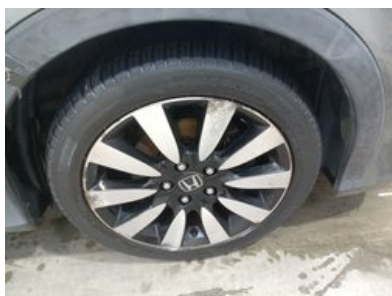
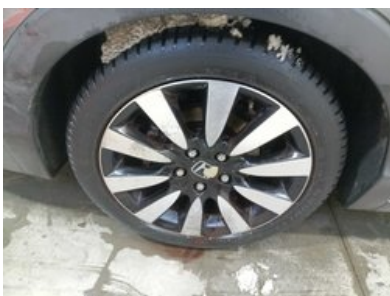
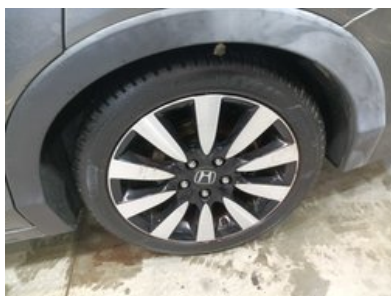
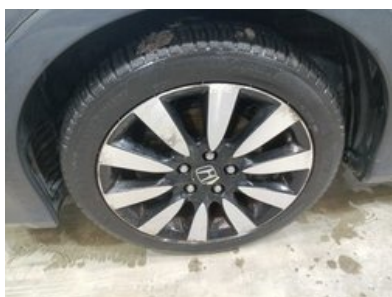
✓ **7. Side:** Wheels - Condition

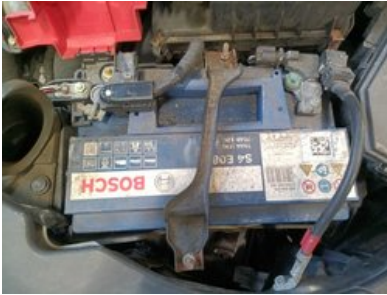
✓ **3. GENERAL ELECTRICS:** Battery

- ✓ 1. Rear Brake Disc (Both)
- ✓ 2. Track Rod End Joint
- ✓ 3. Air Filter Hose
- ✓ 4. Battery
- ✓ 5. Engine Oil & Filter Change
- ✓ 6. Front Wheel Alignment
- ✓ 7. DPF Filter Regeneration/Cleaning

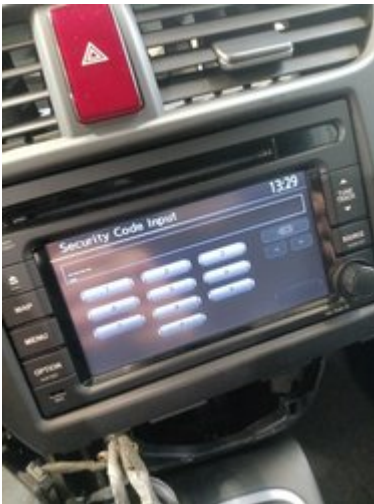
✓ **4. GENERAL ELECTRICS:** Radio Code

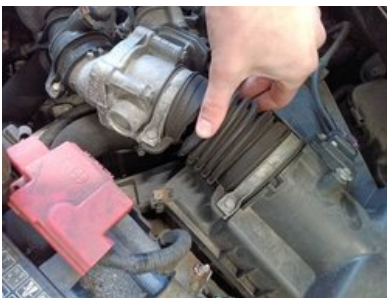
✓ **5. ENGINE:** Air Filter Hose

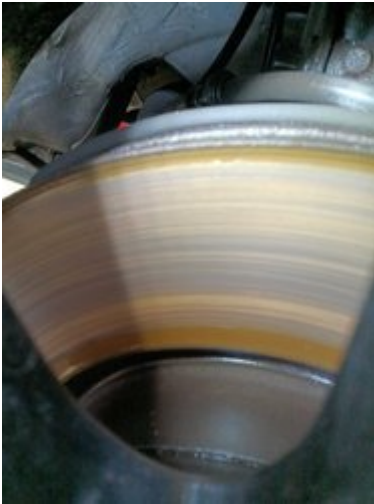
✓ **6. BRAKES:** Front Brake Discs Both

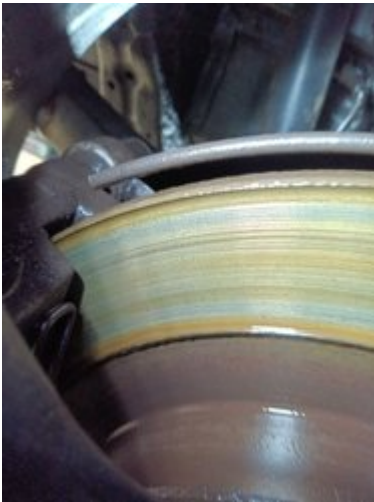
✓ **7. BRAKES:** Rear Brake Disc (Both)

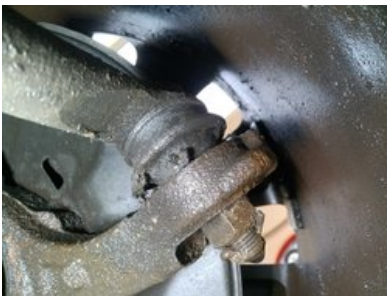
✓ **8. STEERING:** Track Rod End Joint
