# Diagnosis report of 2018 PEUGEOT 308 Executive

During the comprehensive diagnosis conducted by Longo, 14 issues were identified in the vehicle.

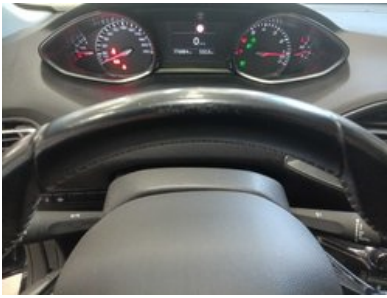
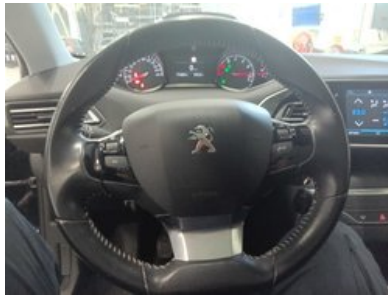
### ✓ 1. Front: Steering Wheel - Condition

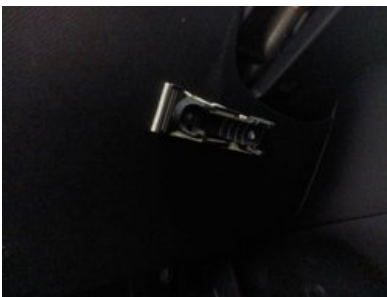
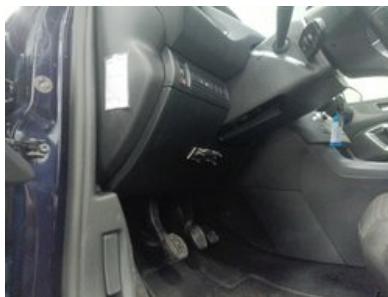
### ✓ 2. Front: Trims - Condition

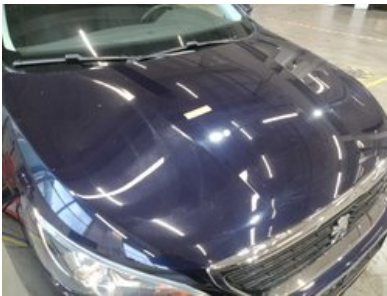
### ✓ 1. Front: Hood - Visual Damage

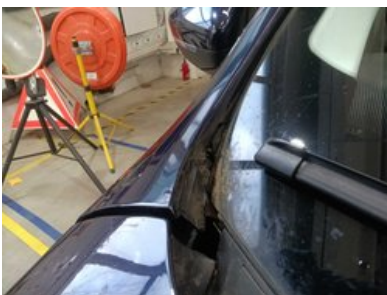
### ✓ 2. Front: Windscreen Integrity - Free from MOT-Excluding Damage

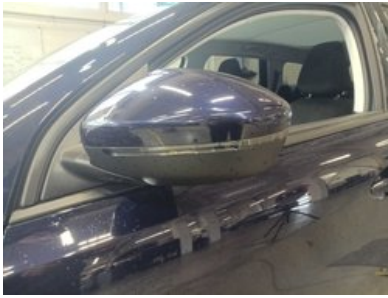
✓ **3. Lights:** Car Side Lights - Basic Functioning, Damage, and Color

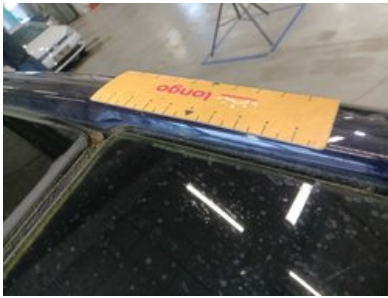
✓ **4. Side:** Left and Right Side - Visual Damage and Scratches

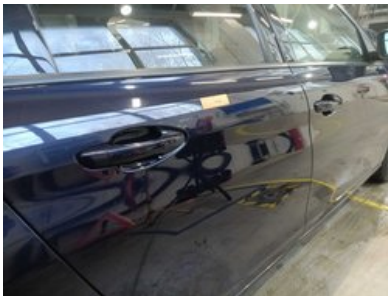
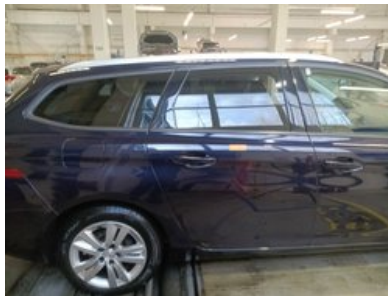
✓ **5. Side:** Left and Right Side - Visual Damage and Scratches

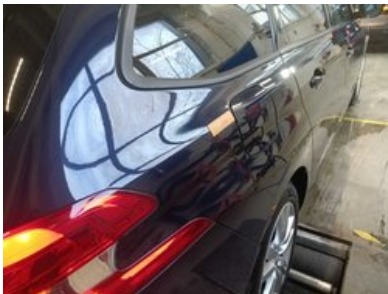
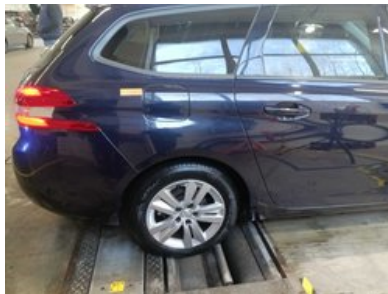
✓ **6. Side:** Left and Right Side - Visual Damage and Scratches

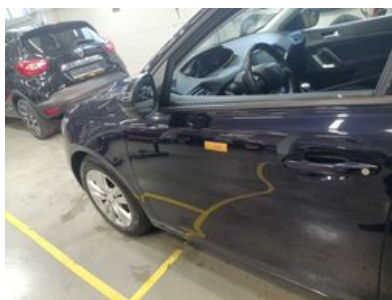
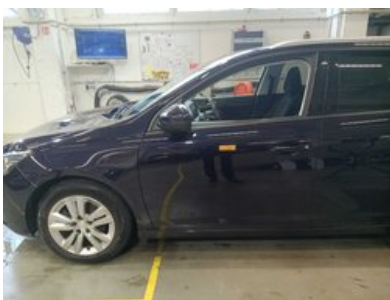
✔ **7. Side:** Left and Right Side - Visual Damage and Scratches

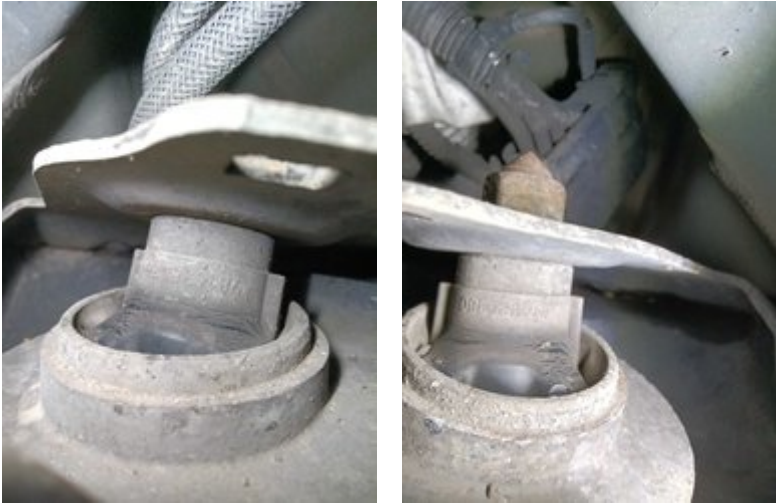
5. OTHER: Suspension Lower Arm

- ✓ 1. Charge Battery
- ✓ 2. Camshaft Drive Belt
- ✓ 3. Anti-Roll Bar Link
- ✓ 4. Engine Oil and Filter
