Diagnosis report of 2017 PEUGEOT 3008 Allure

Preparation and repair report of 2017 PEUGEOT 3008 Allure

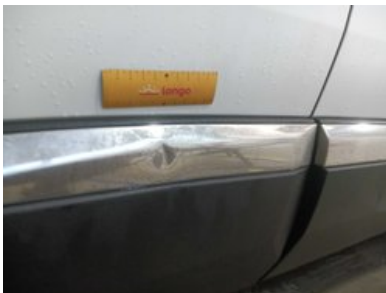
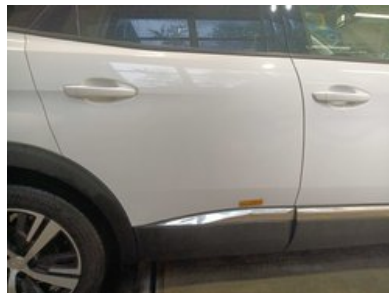
- ✔ **1. Side:** Left and Right Side - Visual Damage and Scratches

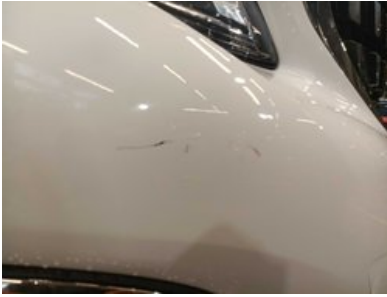
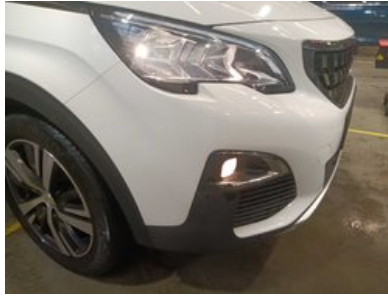
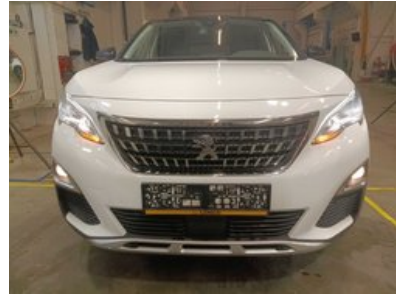
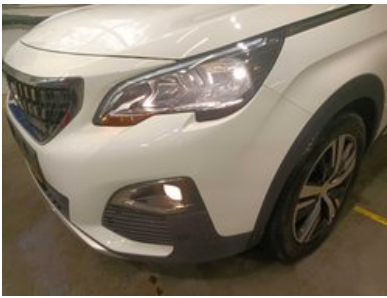
✔ **2. Front:** Front Bumper - Condition and Alignment

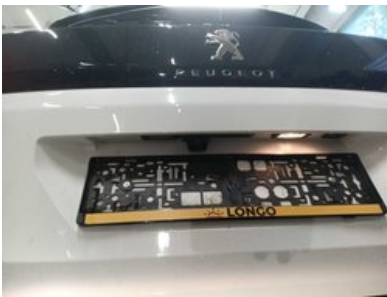
✔ **3. Lights:** Light Bulbs

- ✓ 1. Engine Oil
- ✓ 2. Rear Brake Pads
- ✓ 3. Change Bulb for License Plate Lights

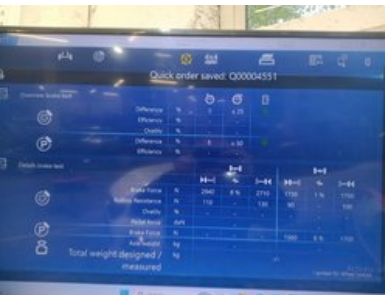
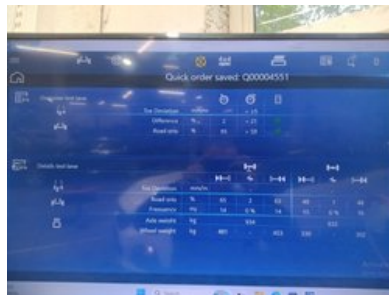
✔ 1. Brake Test Line Results

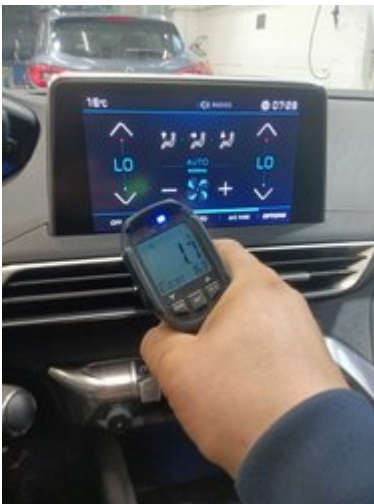
✔ 3. Air-Conditioning Measurement
