# Diagnosis report of 2017 PEUGEOT 2008 Allure

During the comprehensive diagnosis conducted by Longo, 13 issues were identified in the vehicle.

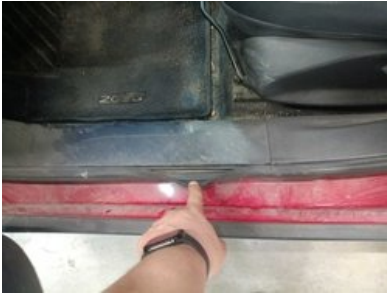
### ✓ 1. Doors: Door Rubber Seals

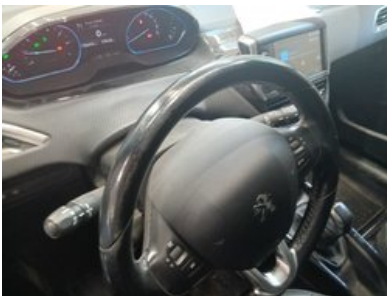
### ✓ 2. Front: Steering Wheel - Condition

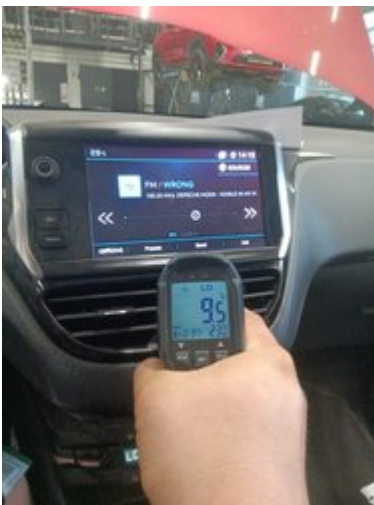
### ✓ 3. Operation: Air-Conditioning System - Functioning

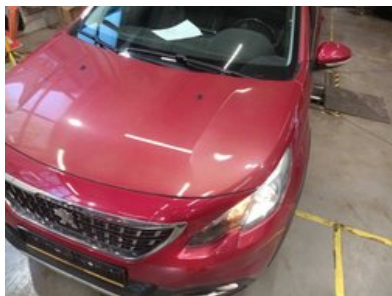
### ✓ 1. Other: Additional Polishing Tasks

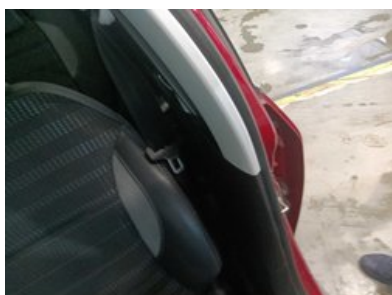
### ✓ 2. Other: Audible Signs (Loose Parts, Rattling, Etc.)

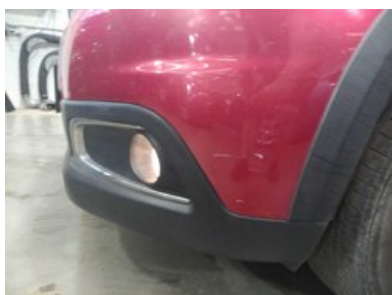
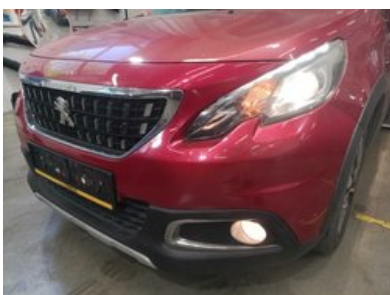
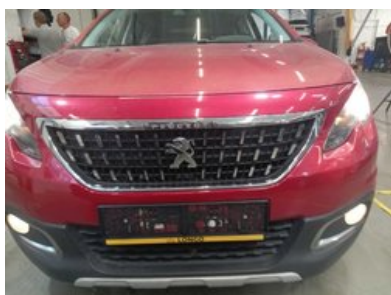
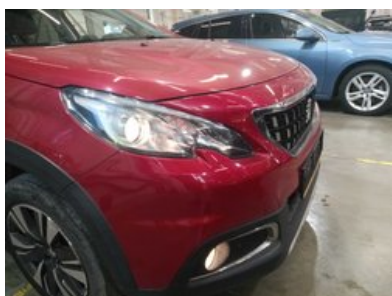
### ✓ 3. Front: Front Bumper - Condition and Alignment

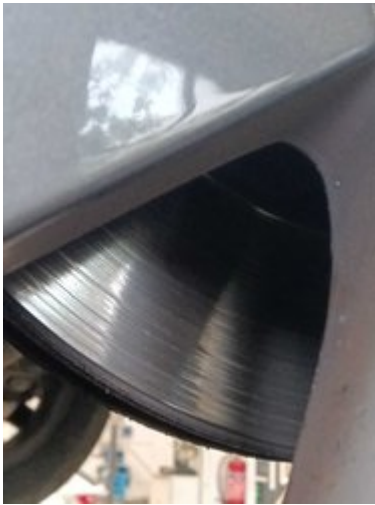
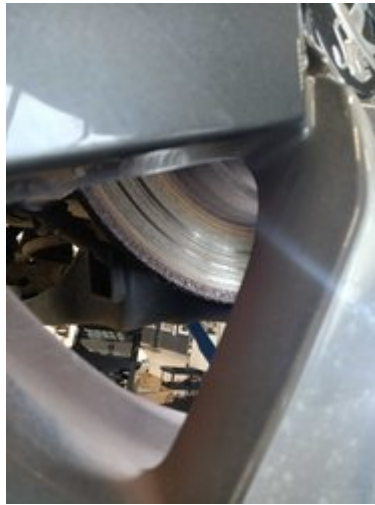
### ✓ 1. BRAKES: Front and Rear Disks

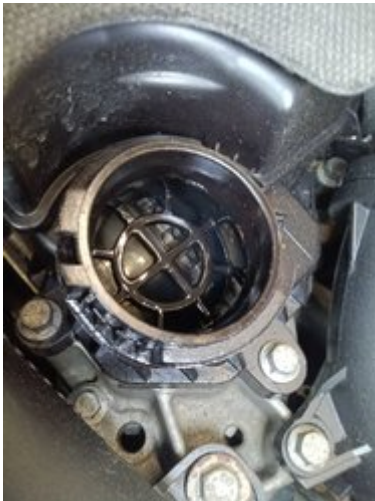
### ✓ 2. ENGINE: Camshaft Drive Belt

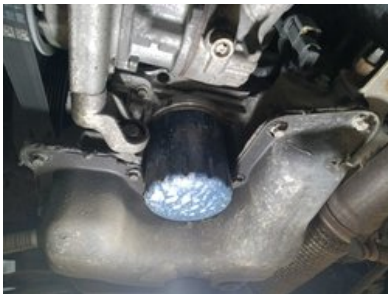
### ✓ 3. ENGINE: Oil Pan

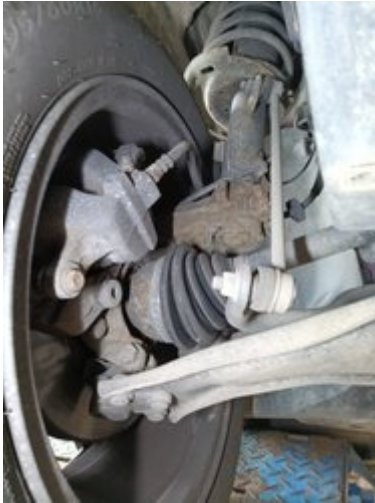
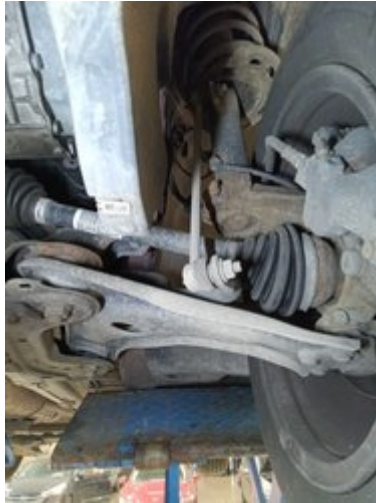
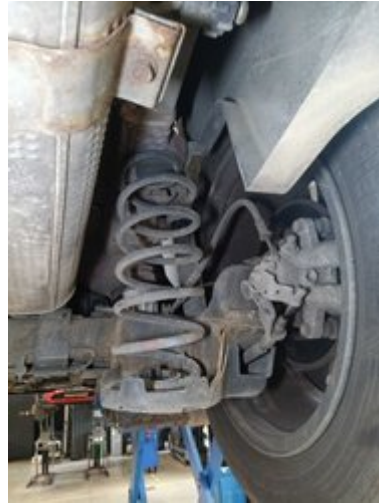
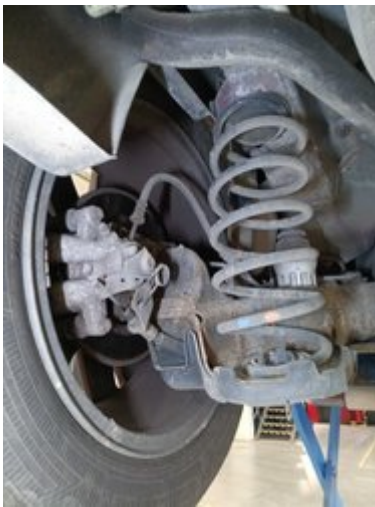
✓ **4. SUSPENSION:** Suspension Condition

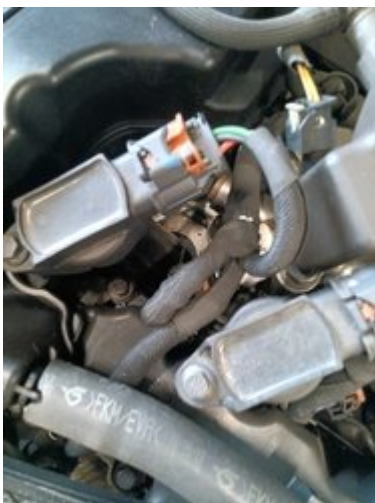
✓ **6. ENGINE MANAGEMENT - FUEL:** Injectors (All)

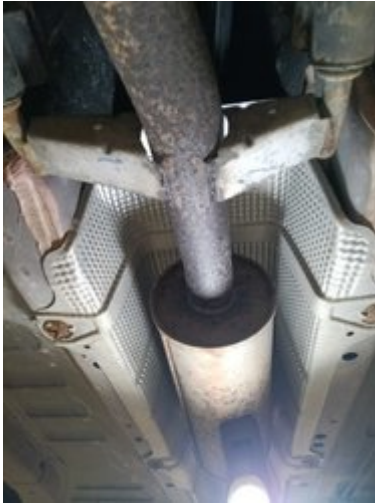
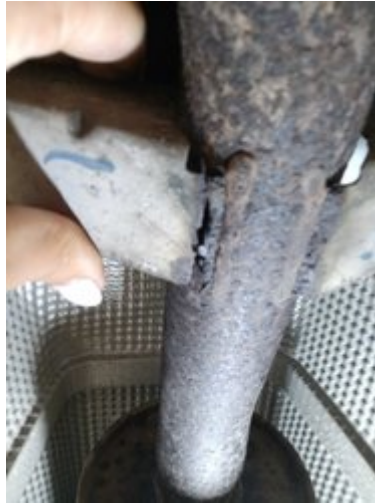
✔ **7. EXHAUST SYSTEM:** Exhaust Manifold

- ✓ 1. Engine Oil & Filter Change
- ✓ 2. Exhaust Manifold
- ✓ 3. Seatbelt Repair
