# Diagnosis report of 2018 PEUGEOT 2008 Allure

# Preparation and repair report of 2018 PEUGEOT 2008 Allure

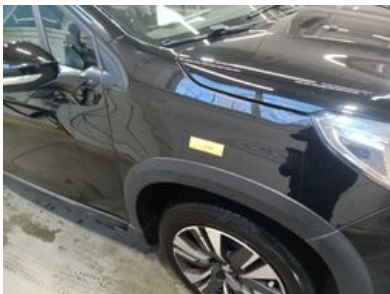
✔ **1. Side:** Left and Right Side - Visual Damage and Scratches

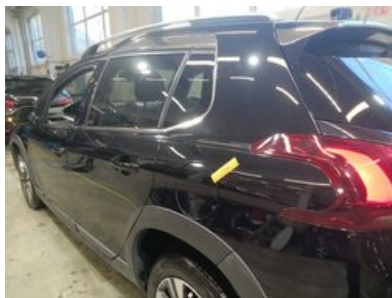
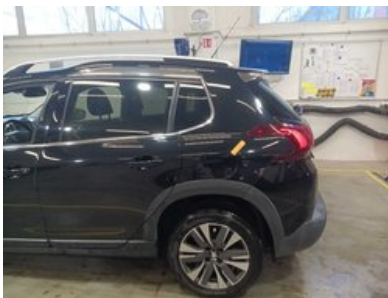
✓ **2. Side:** Left and Right Side - Visual Damage and Scratches

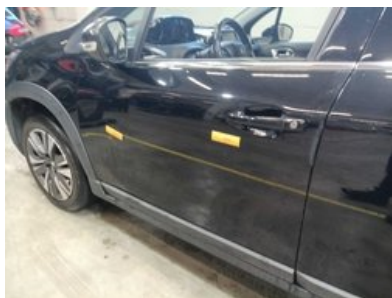
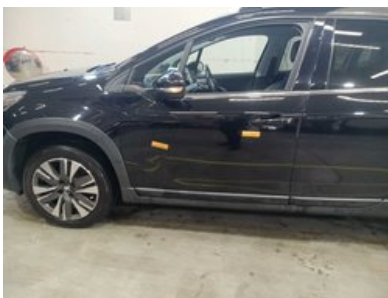
✓ **3. Side:** Left and Right Side - Visual Damage and Scratches

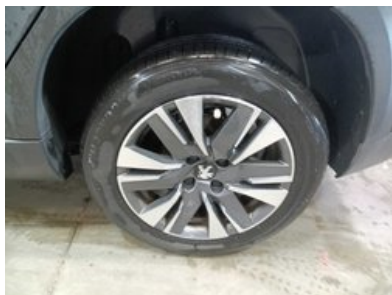
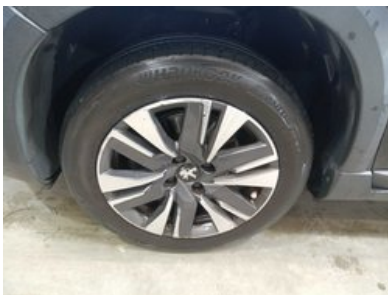
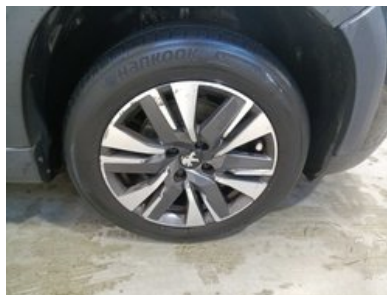
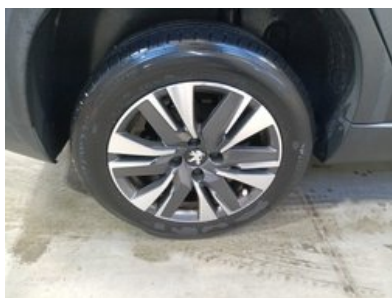
✓ **4. Side:** Wheels - Condition

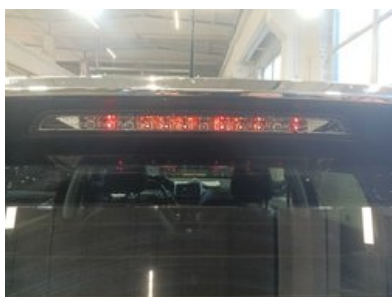
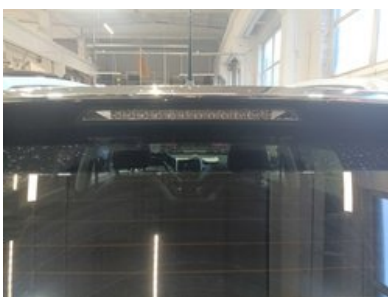
✓ **5. Lights:** Rear Lights (Brake, Fog, Indicator) - Basic Functioning, Damage, and Color

- ✓ 1. Repair Bumper Corners
- ✓ 2. Change Brake Lights

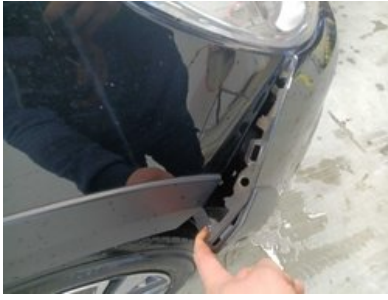
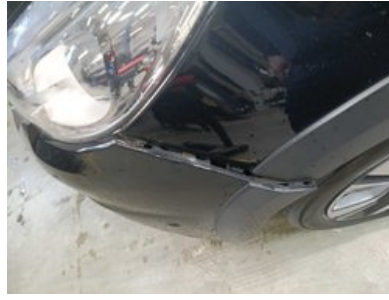
✔ **6. Front:** Front Bumper - Condition and Alignment

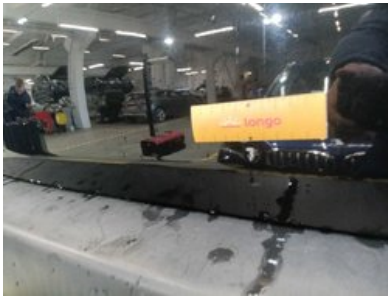
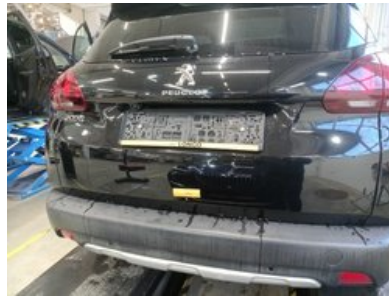
✔ **7. Rear:** Trunk - Visual Damage

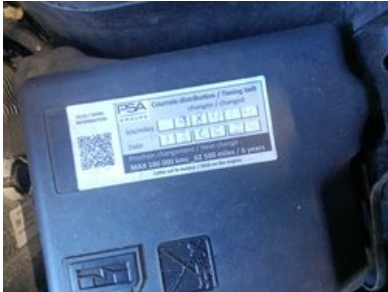
✓ **1. ENGINE:** Camshaft Drive Belt

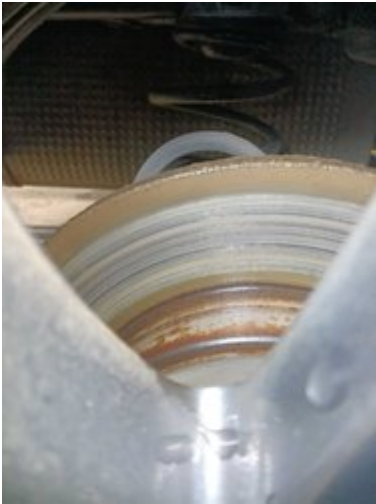
✓ **2. BRAKES:** Rear Brake Disc (Both)
