# Diagnosis report of

## 2015 VOLKSWAGEN GOLF 7 GTE

Diagnosis details

Summary of diagnosed issues

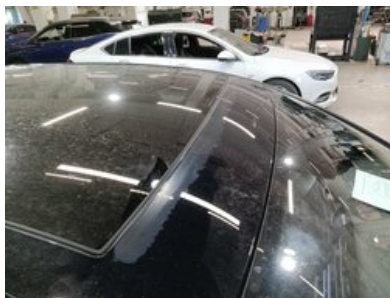
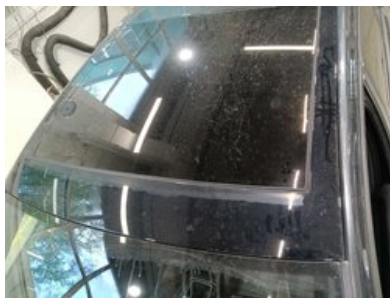
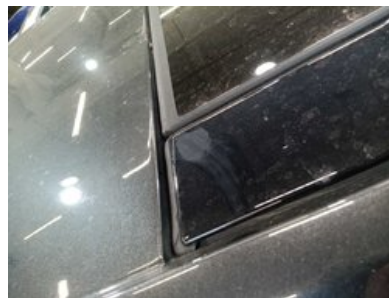
✔ **2. Other:** Roof - Visual Damage (e.g., Hail Damage)

- ✓ 1. Paint Roof

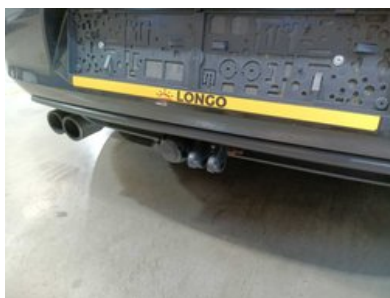
✔ **3. Rear:** Tow Hitch (Attachment, Removal Mechanism, External Light Connector, Connector Thickness)

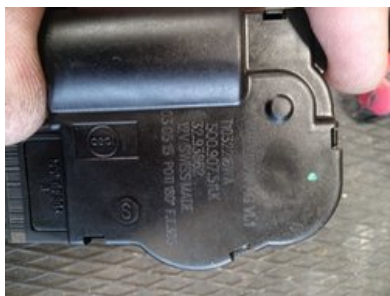
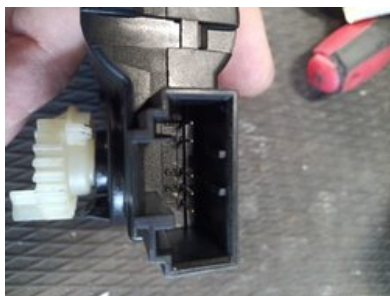
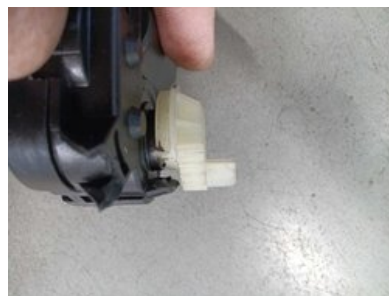
✔ **1. GENERAL ELECTRICS:** Throttle Actuator

- ✓ 1. Throttle Actuator Motor
- ✓ 2. Engine Oil & Filter Change
- ✓ 3. Hybrid Charging Cable
