# Diagnosis report of 2015 PEUGEOT 308 Executive

# Preparation and repair report of 2015 PEUGEOT 308 Executive

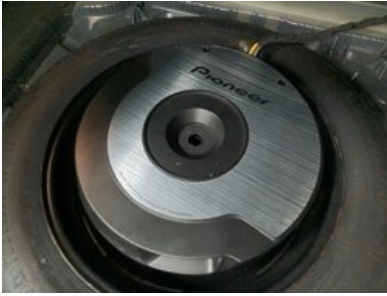
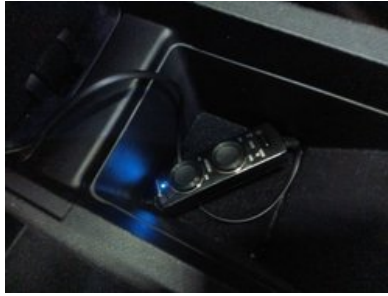
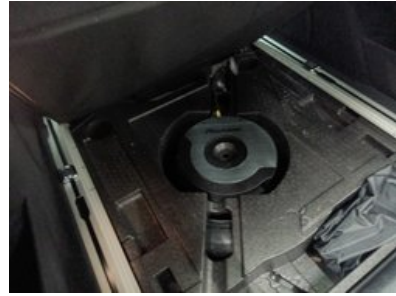
### ✔ 1. Operation: Navigation and Radio System - Operation

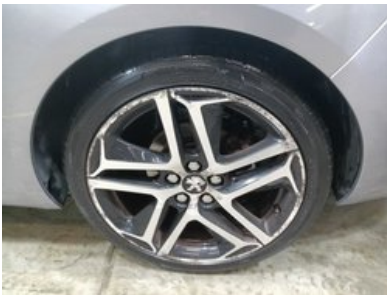
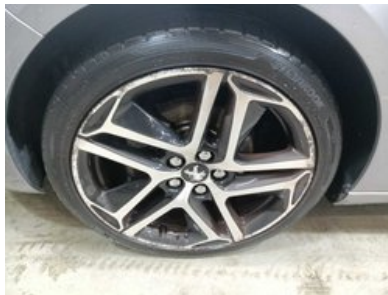
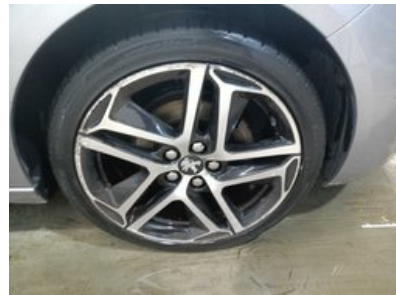
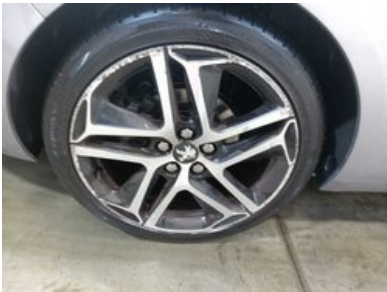
### ✔ 1. Side: Wheels - Condition

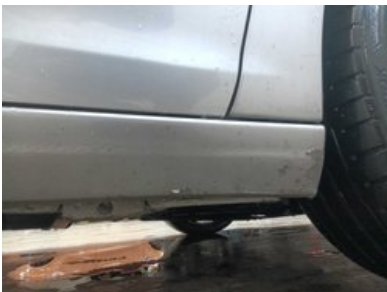
### ✔ 2. Side: Left and Right Side - Visual Damage and Scratches

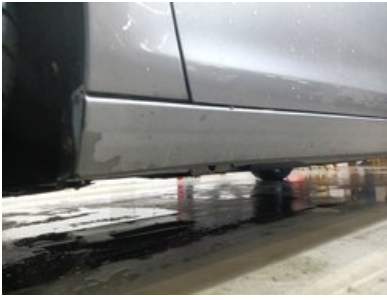
✓ **3. Side:** Left and Right Side - Visual Damage and Scratches

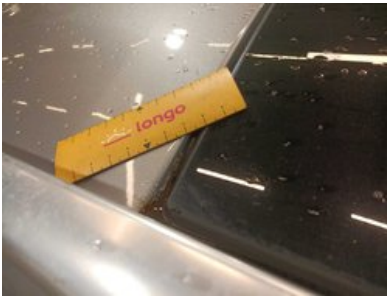
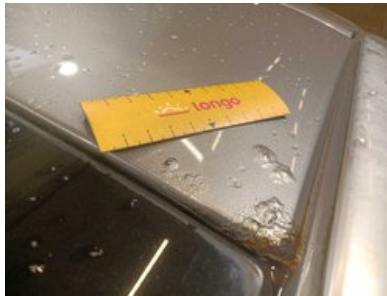
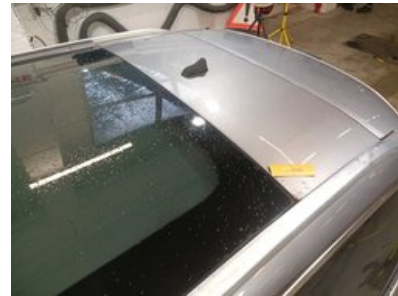
✓ **4. Other:** Roof - Visual Damage (e.g., Hail Damage)

- ✓ 1. Paint Roof

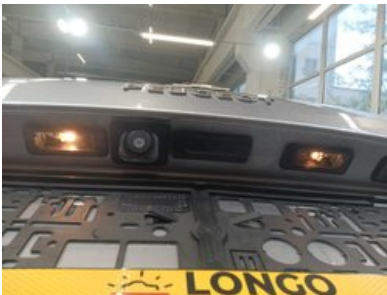
✓ **5. Lights:** License Plate Lighting System - Functioning

- ✓ 1. Oil Pressure Sensor
- ✓ 2. Air Filter Box Top
- ✓ 3. Change Number Plate Lights
- ✓ 4. Engine Oil & Filter Change
- ✓ 5. AdBlue Injector

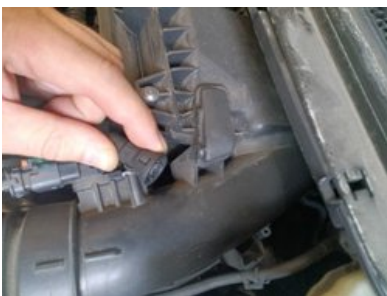
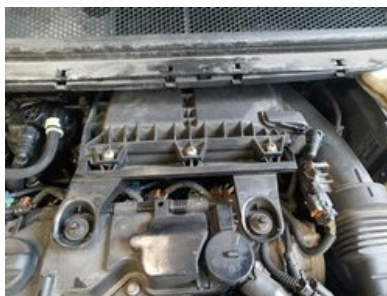
✓ **2. ENGINE:** Air Filter Box Top

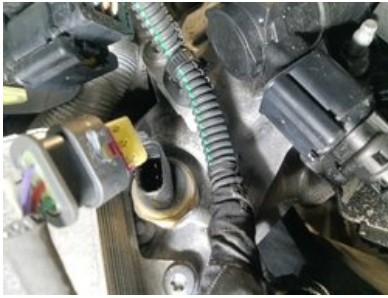
✓ **3. ENGINE:** Oil Pressure Sensor

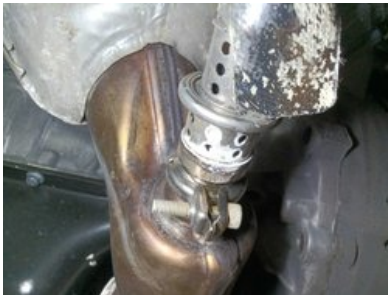
✓ **4. EXHAUST SYSTEM:** AdBlue Injector

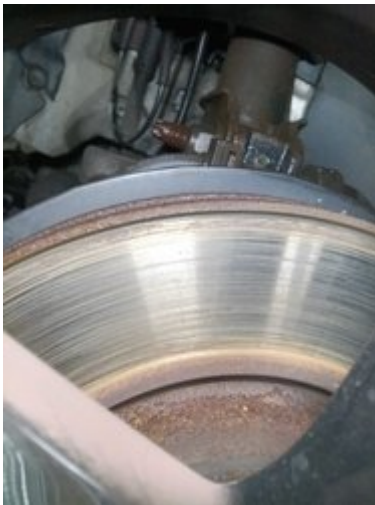
✓ **5. BRAKES:** Front Brake Discs Both with Pads

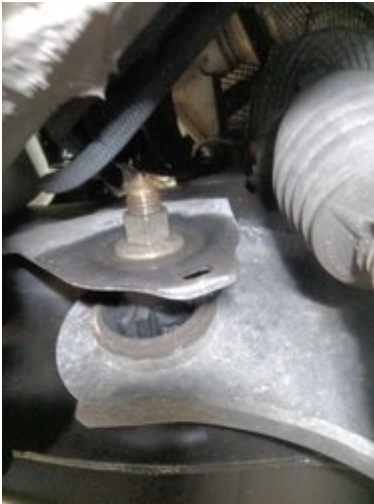
✓ **6. SUSPENSION:** Suspension Lower Arm Both

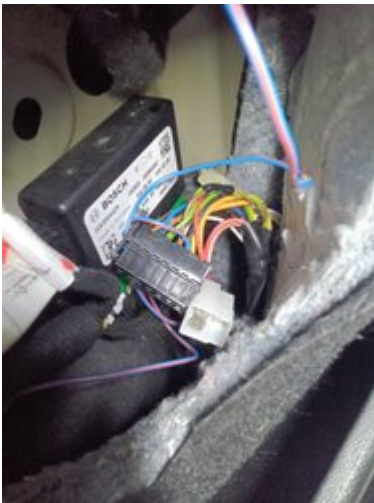
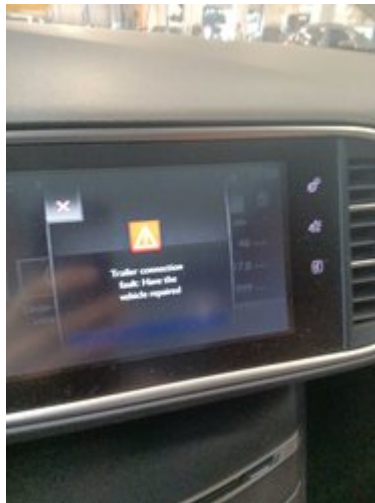
✓ **7. BODY - REAR SECTION:** Tow Bar Module
