# Diagnosis report of 2018 PEUGEOT 5008 Allure

During the comprehensive diagnosis conducted by Longo, 8 issues were identified in the vehicle.

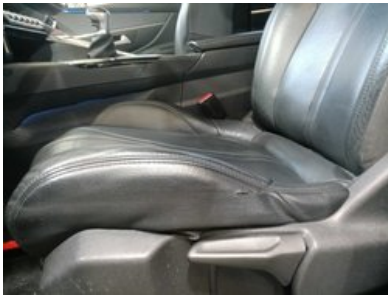
### ✓ 1. Seats: All Seats - Condition

- ✓ 1. Repair Seat

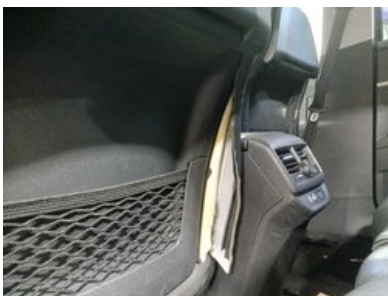
### ✓ 2. Seats: All Seats - Condition

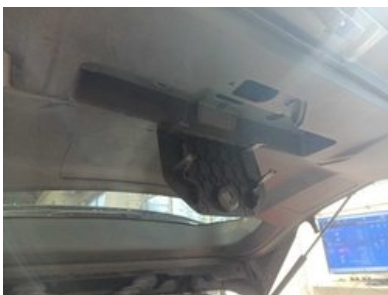
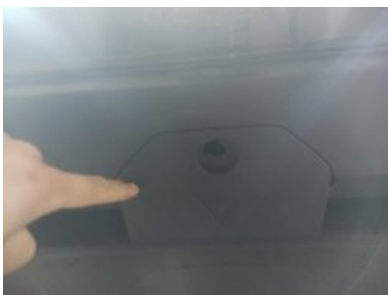
### ✓ 3. Inside: Trims - Condition

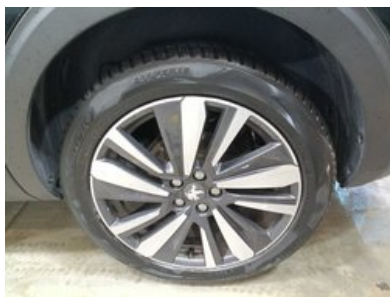
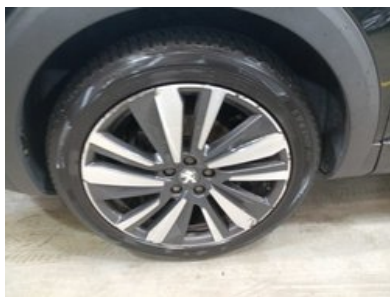
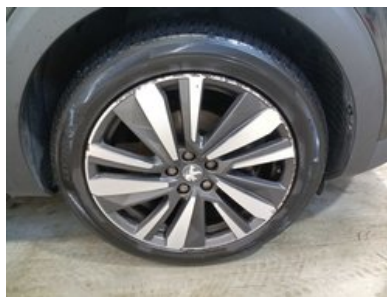
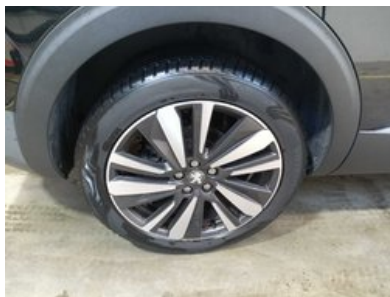
### ✓ 1. Side: Wheels - Condition

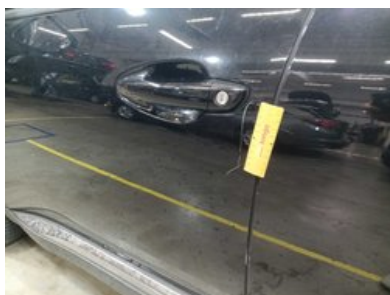
### ✓ 2. Side: Left and Right Side - Visual Damage and Scratches

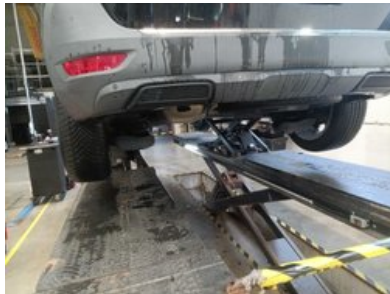
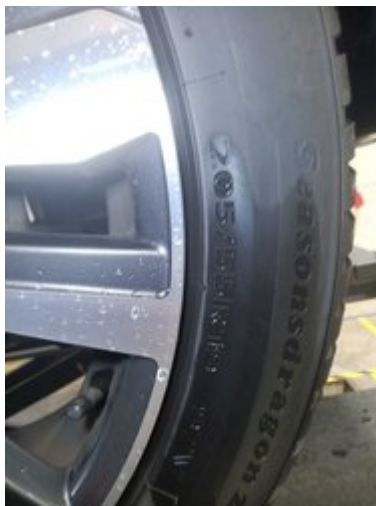
✓ **2. OTHER:** Change Tires

- ✓ 1. Change Tires
- ✓ 2. Engine Oil & Filter Change

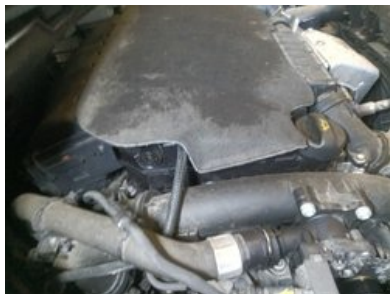
✓ **3. ENGINE:** Camshaft Valve Cover & Gasket
