# Diagnosis report of 2016 PEUGEOT 2008 Allure

# Preparation and repair report of 2016 PEUGEOT 2008 Allure

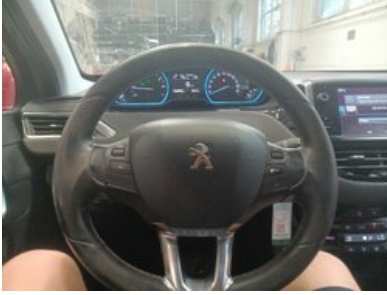
- ✓ **1. Front:** Steering Wheel - Condition

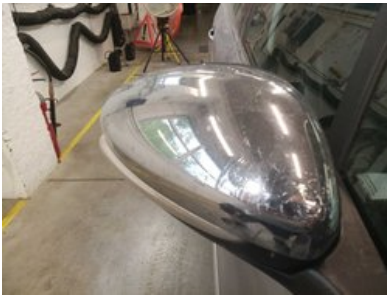
- ✓ **1. Side:** Exterior Mirrors - Mirror Integrity and Car Attachment

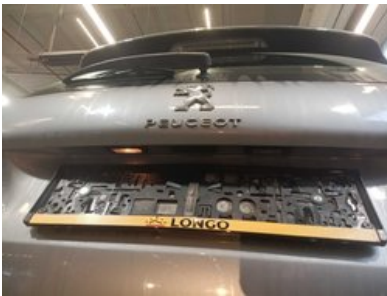
- ✓ **2. Lights:** Light Bulbs

- ✓ 1. Engine Oil & Filter Change
- ✓ 2. Change Bulb for License Plate Lights
- ✓ 3. Change Tires

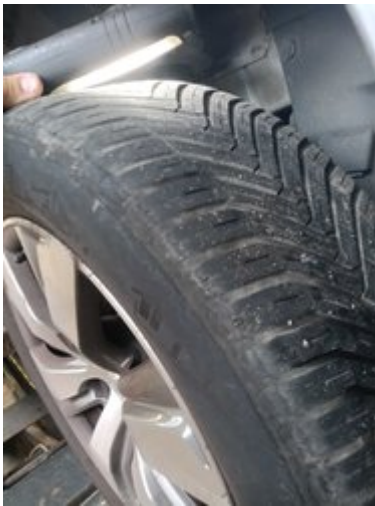
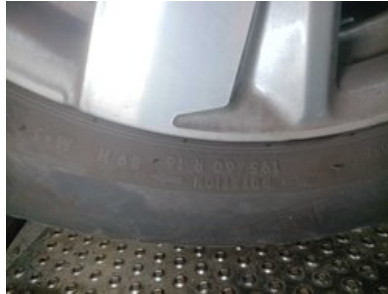
✓ **2. OTHER:** Change Tires

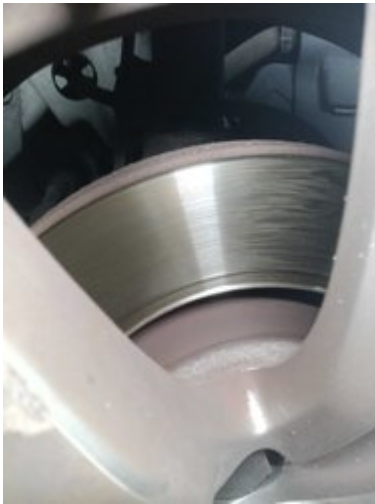
✓ **3. BRAKES:** Front Brake Discs Both

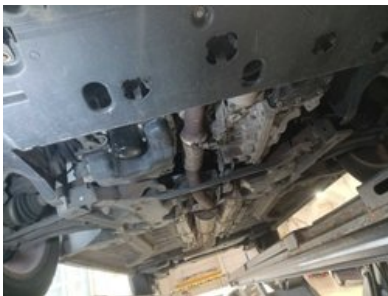
✓ **4. BODY - FRONT SECTION:** Missing Engine Cover
