# Diagnosis report of 2018 PEUGEOT 3008 Allure

## Summary of diagnosed issues

During the comprehensive diagnosis conducted by Longo, 8 issues were identified in the vehicle.

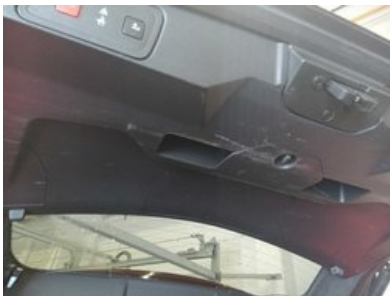
### ✔ 1. Inside: Trims - Condition

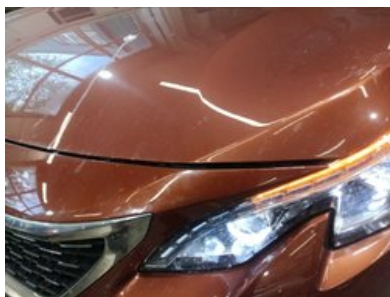
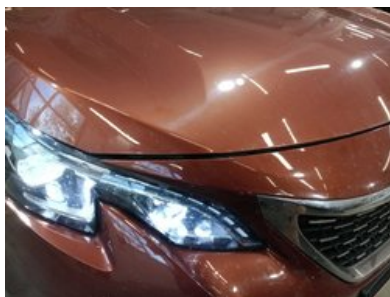
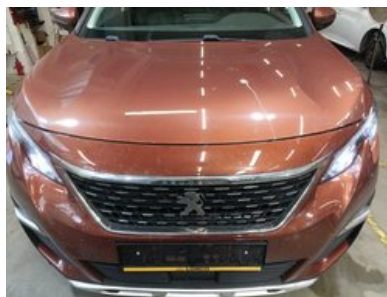
### ✔ 1. Side: Body Panel Geometry

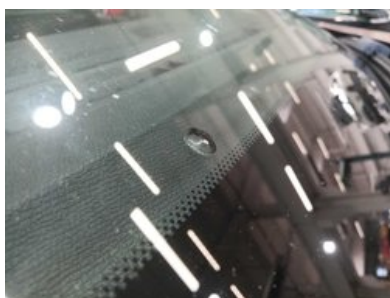
### ✔ 2. Front: Windscreen Integrity - Free from MOT-Excluding Damage

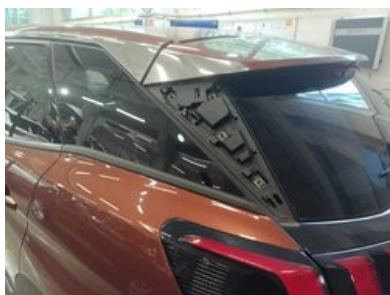
### ✔ 3. Rear: Trunk - Visual Damage

- ✓ 1. Trunk Trim

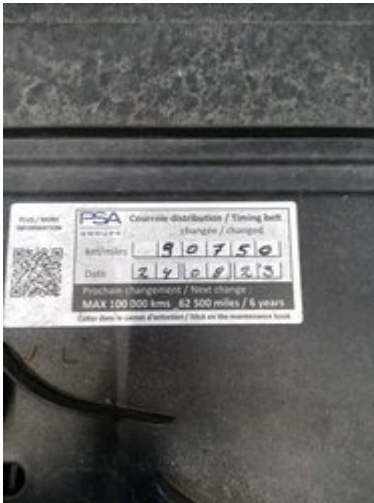
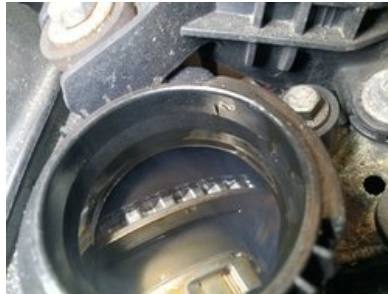
### ✓ 1. ENGINE: Camshaft Drive Belt

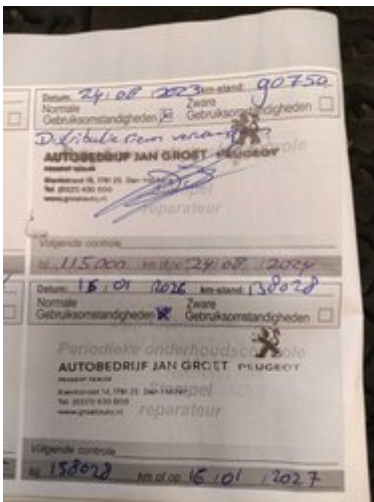
### ✓ 2. OTHER: Engine Oil & Filter Change

- ✓ 1. Engine Oil & Filter Change

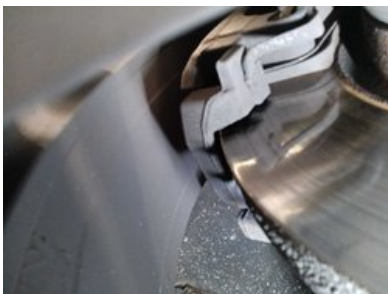
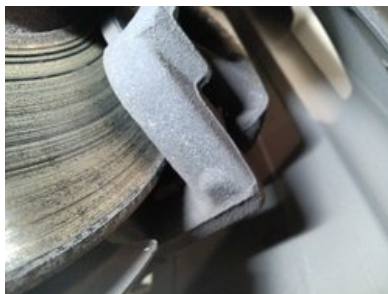
### ✓ 3. BRAKES: Brakes Condition

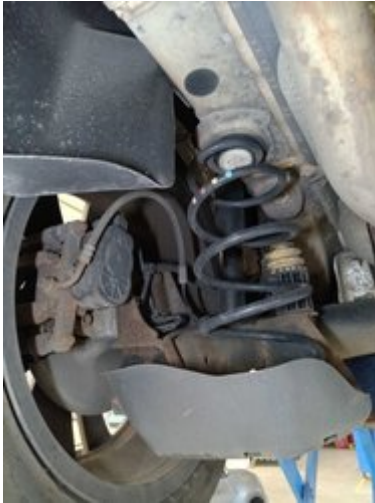
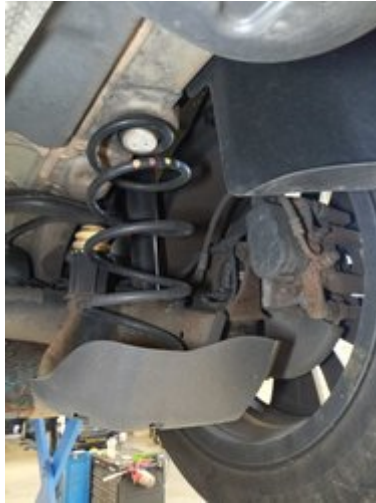
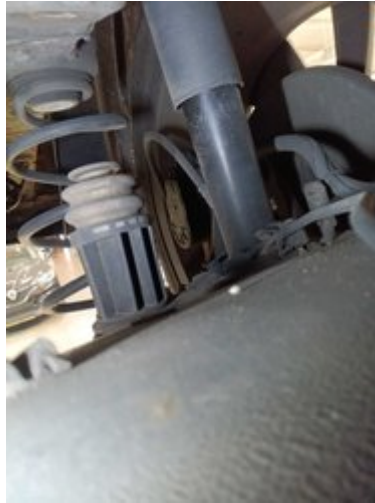
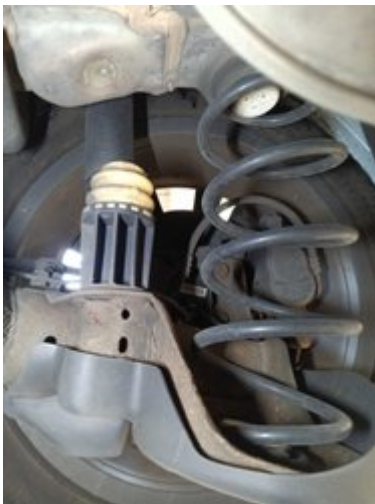
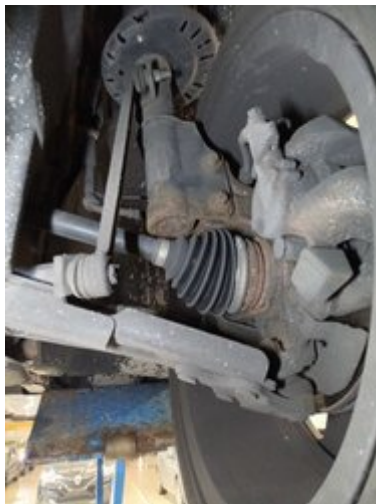
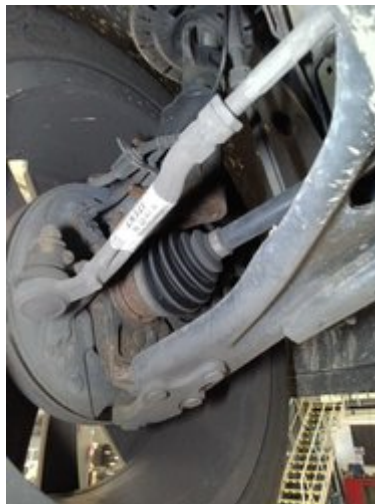
✓ **4. SUSPENSION:** Suspension Condition
