# Diagnosis report of 2017 OPEL MOKKA X Innovation

# Preparation and repair report of 2017 OPEL MOKKA X Innovation

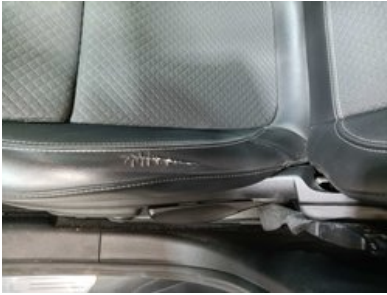
✓ **1. Seats:** All Seats - Condition

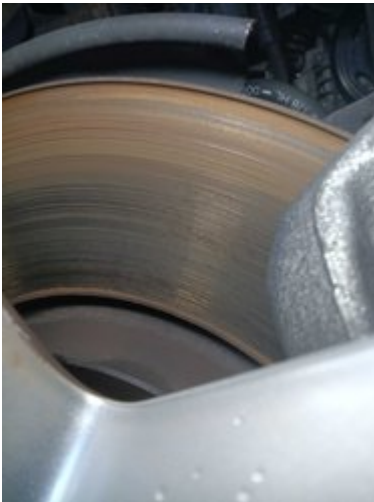
✓ **1. BRAKES:** Front Brake Discs Both

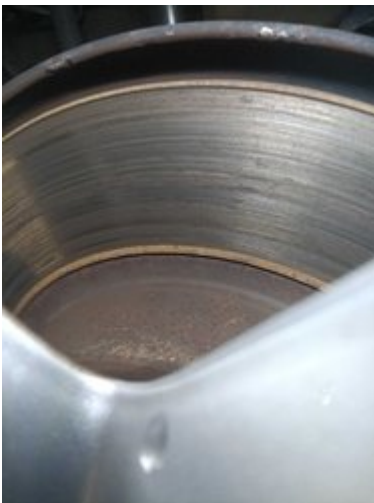
✓ **2. BRAKES:** Rear Brake Disc (Both)

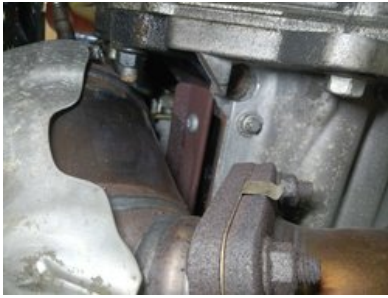
✓ 4. AUTOMATIC TRANSMISSION: Oil Cooler

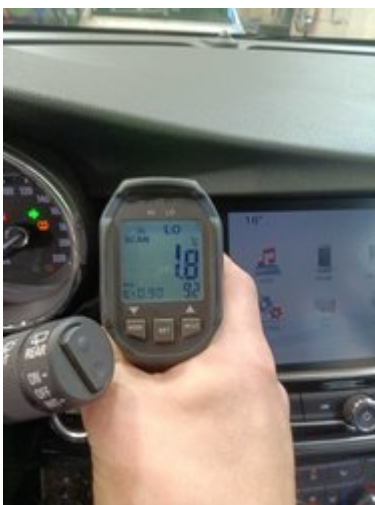
✓ 2. Air-Conditioning Measurement
