# Diagnosis report of 2020 OPEL GRANDLAND X Business Executive

Diagnosis report of

2020 OPEL GRANDLAND X Business Executive

Summary of diagnosed issues

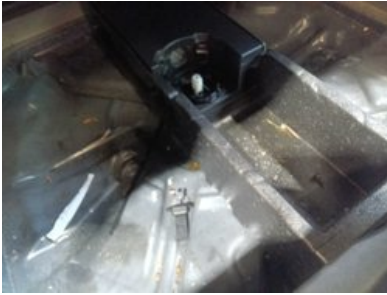
✓ **1. Inside:** Trims - Condition

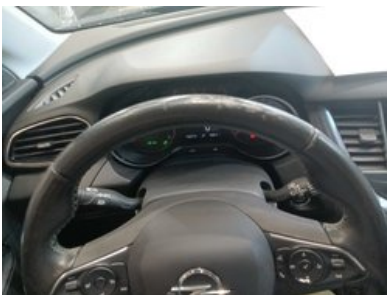
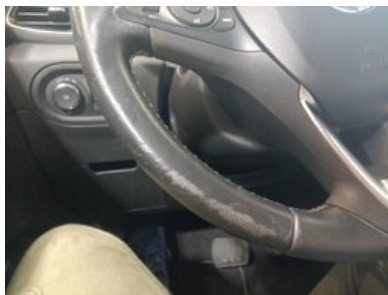
✓ **2. Front:** Steering Wheel - Condition

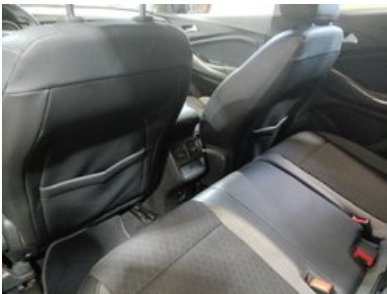
✓ **3. Seats:** All Seats - Condition

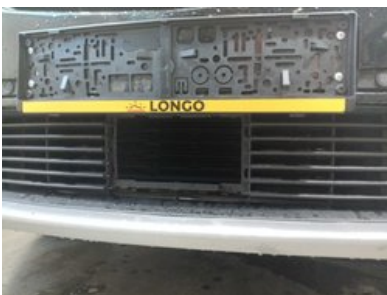
✓ **1. Front:** Front Grille - Condition

- ✓ 1. Other: Repair Bumper Trim
- ✓ 2. Change Bumper Grills
- ✓ 3. Water In Trunk
- ✓ 4. Headlamp Alignment

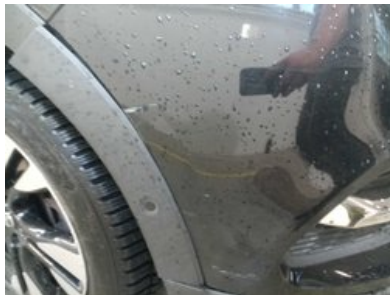
✓ **2. Front:** Front Bumper - Condition and Alignment

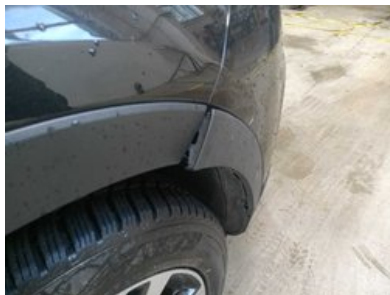
✓ **3. Side:** Left and Right Side - Visual Damage and Scratches

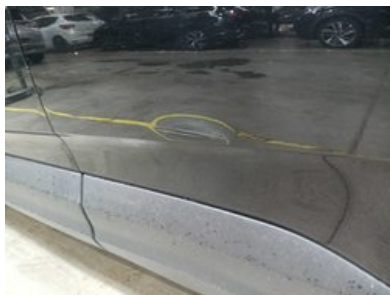
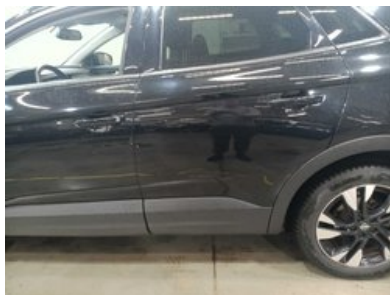
✓ **4. Side:** Left and Right Side - Visual Damage and Scratches

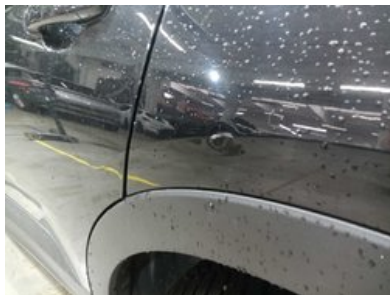
✓ **5. Side:** Left and Right Side - Visual Damage and Scratches

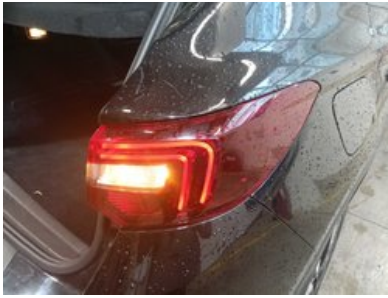
✓ **6. Lights:** Rear Lights (Brake, Fog, Indicator) - Basic Functioning, Damage, and Color

- ✓ 1. Repair Rear Lights (Paintshop)

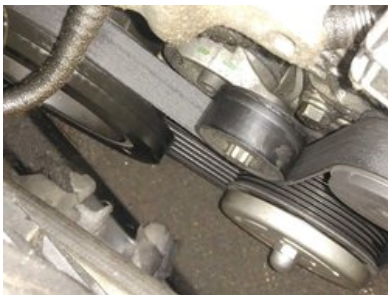
✓ **1. ENGINE:** Auxiliary Drive Belt

- ✓ 1. Auxiliary Drive Belt
- ✓ 2. Engine Oil & Filter Change
- ✓ 3. Driveshaft Joint Gaiter - Outer Left

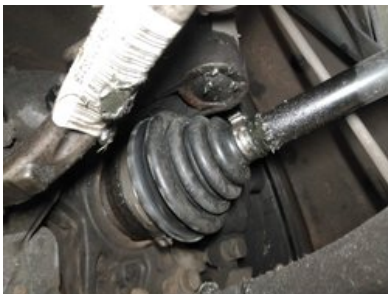
✓ **3. FINAL DRIVE, SHAFT & AXLES:** Driveshaft Joint Gaiter - Outer Left

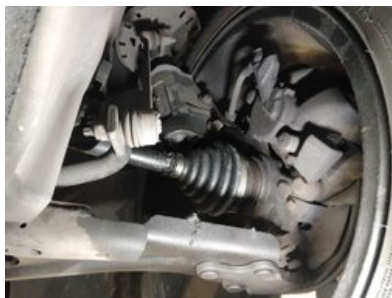
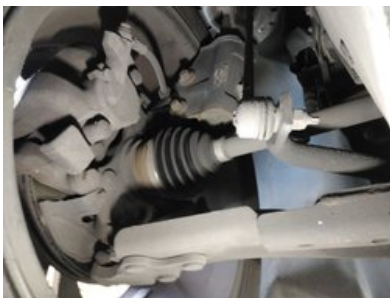
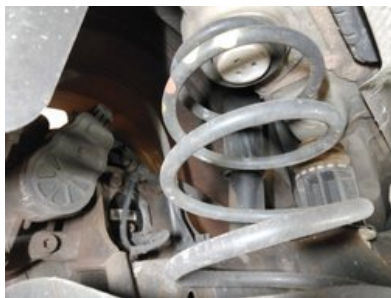
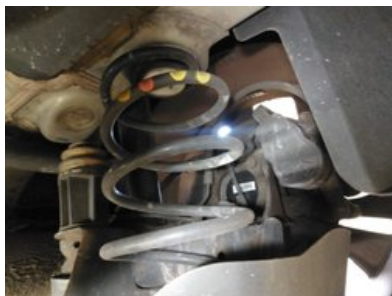
✓ **4. SUSPENSION:** Suspension Inspection

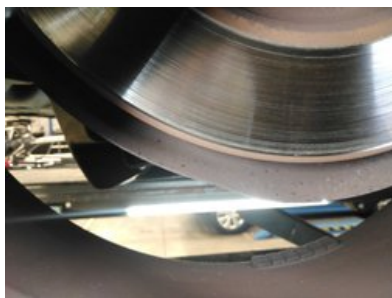
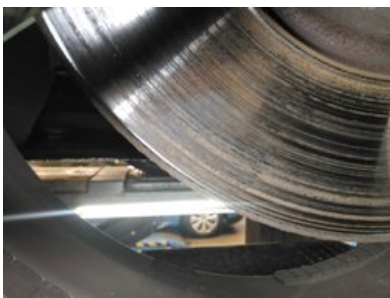
✓ **5. BRAKES:** Brakes Inspection

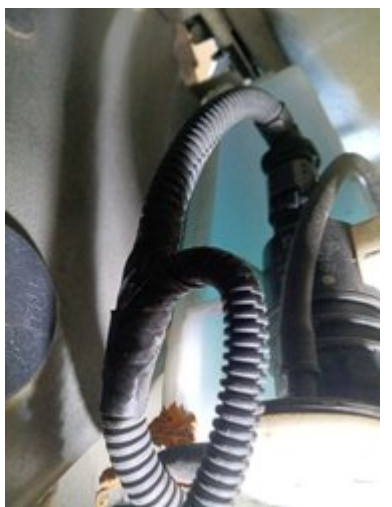
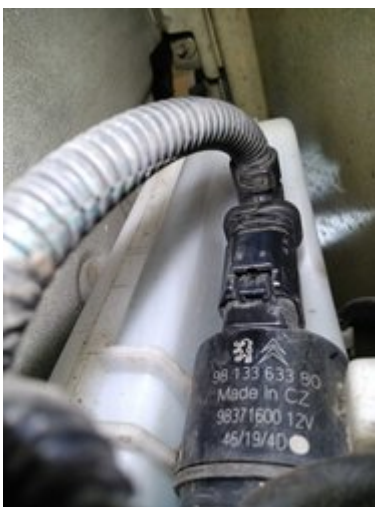
✓ **6. GENERAL ELECTRICS:** Front Washer Motor
