# Diagnosis report of 2015 OPEL ZAFIRA TOURER Business+

During the comprehensive diagnosis conducted by Longo, 16 issues were identified in the vehicle.

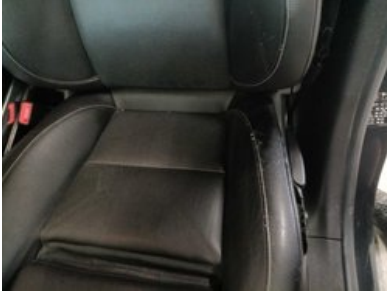
- ✓ **1. Seats:** All Seats - Condition

- ✓ 1. Change Seat Side Plastic

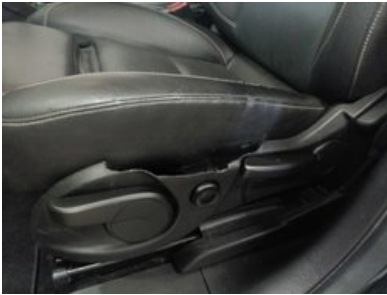
- ✓ **2. Seats:** All Seats - Condition

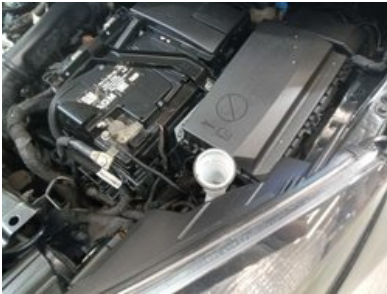
- ✓ **1. Front:** Window Washer Fluid Level (In Winter Also Winter-Adequate Fluid)

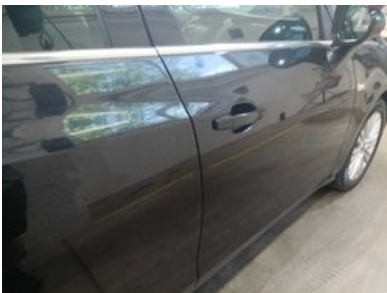
- ✓ **2. Side:** Left and Right Side - Visual Damage and Scratches

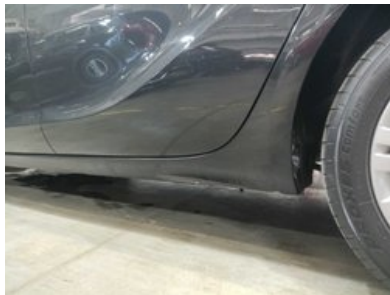
✓ **3. Side:** Left and Right Side - Visual Damage and Scratches

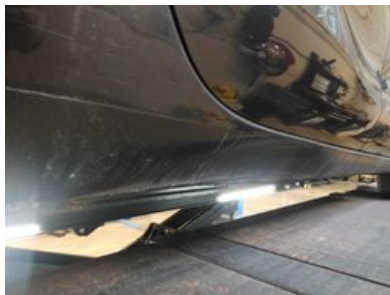
✓ **4. Side:** Left and Right Side - Visual Damage and Scratches

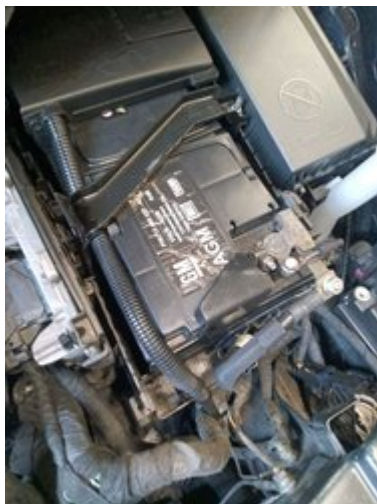
✓ **1. OTHER:** Charge Battery

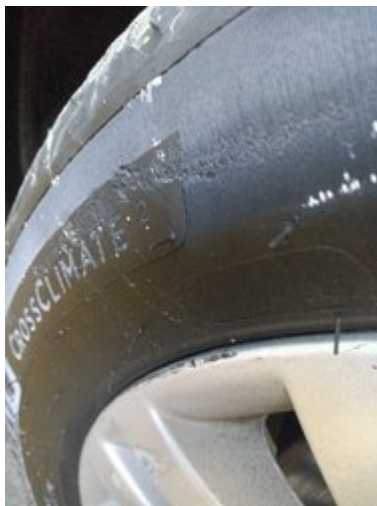
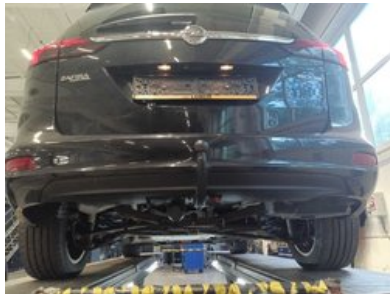
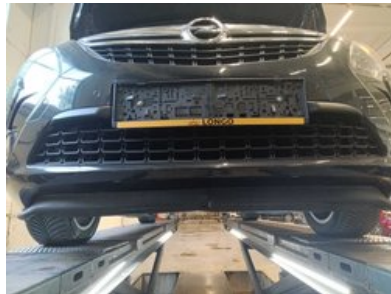
✓ **3. OTHER:** Change Tires

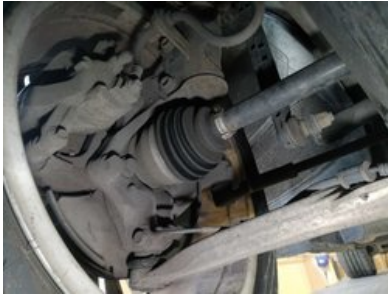
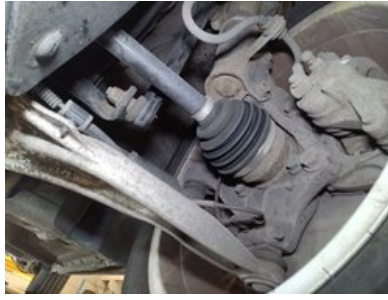
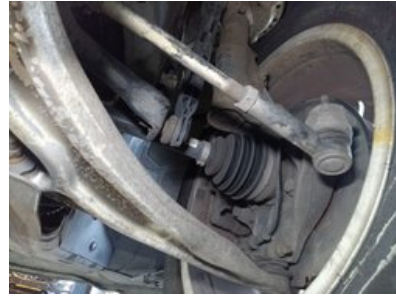
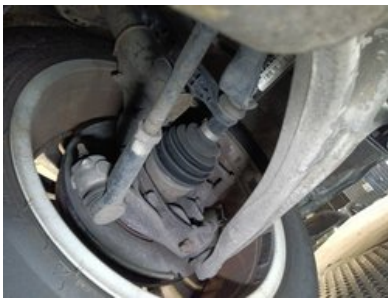
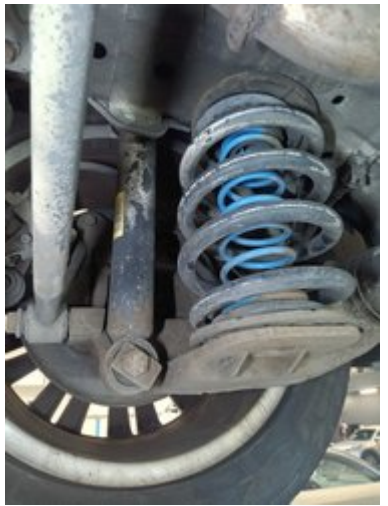
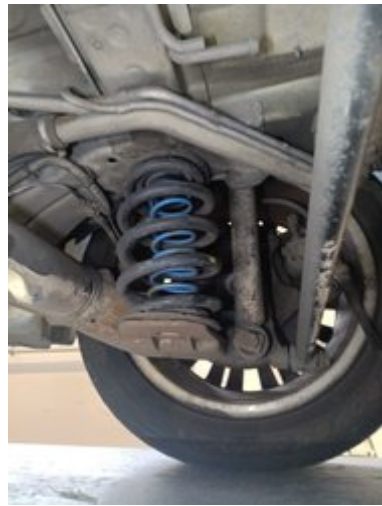
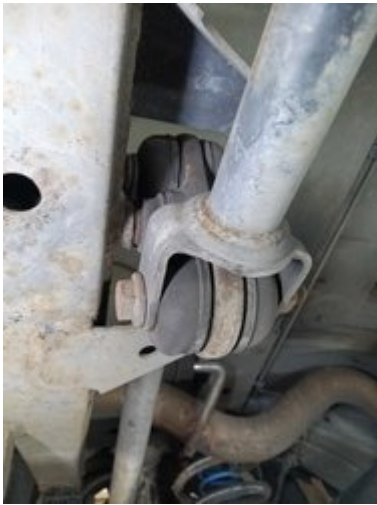
✓ **4. SUSPENSION:** Suspension Condition

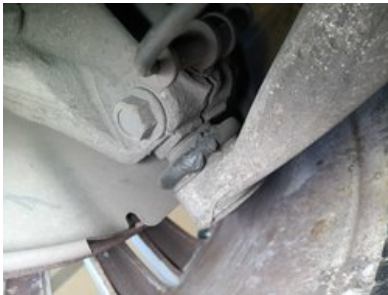
✓ **5. SUSPENSION:** Ball Joint Lower

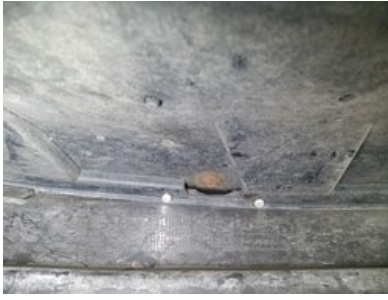
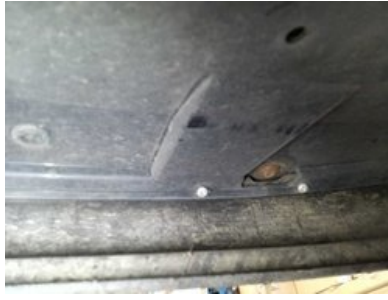
✔ **6. BODY - FRONT SECTION:** Spoiler

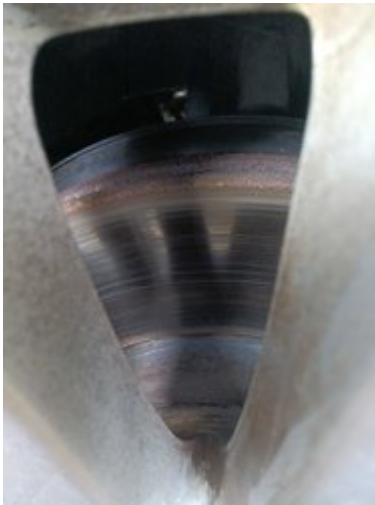
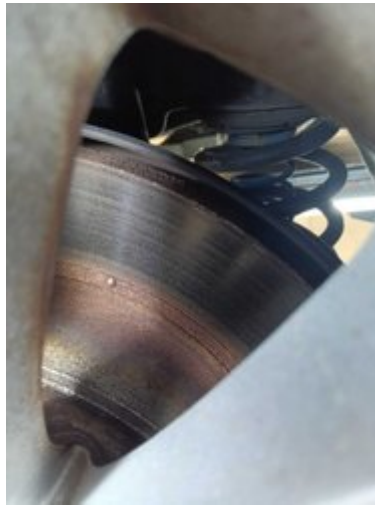
✔ **7. BRAKES:** Brakes Condition

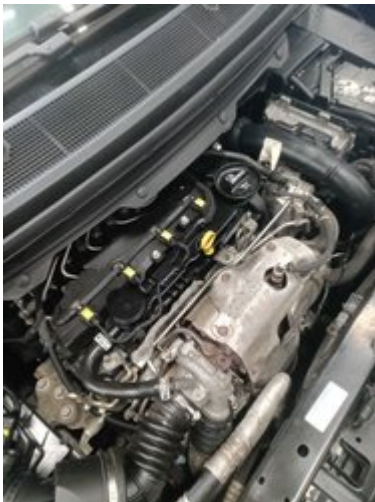
✔ **8. ENGINE:** Camshaft Drive Chain

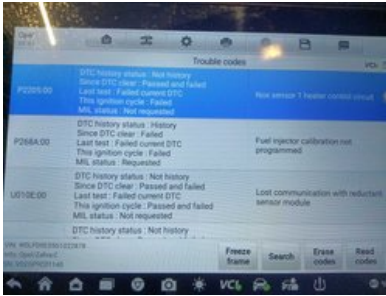
## 9. ENGINE MANAGEMENT - FUEL: Injector Calibration

- ✓ 1. Injector Calibration
- ✓ 2. NOx Sensor 1

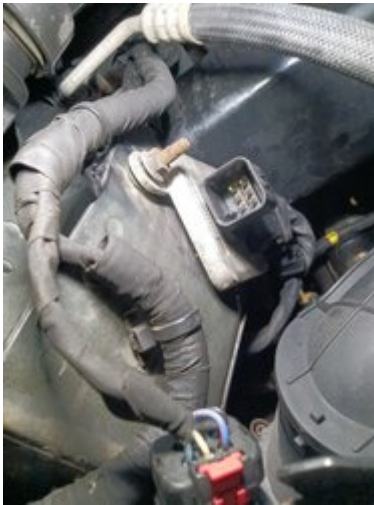
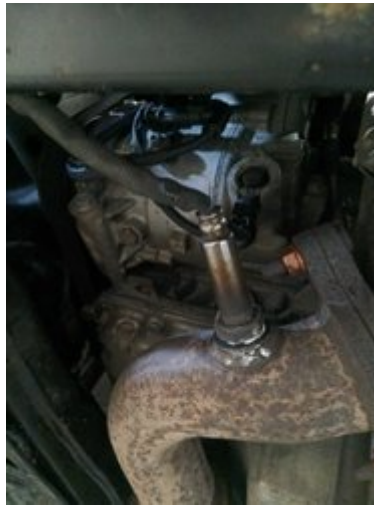
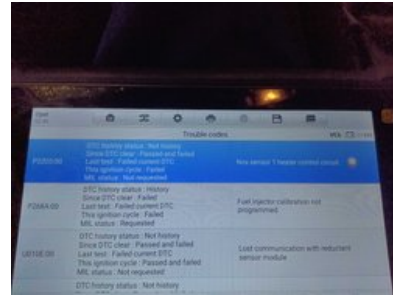
## 10. EXHAUST SYSTEM: NOx Sensor 1
