# Diagnosis report of 2015 RENAULT CAPTUR Intens

# Preparation and repair report of 2015 RENAULT CAPTUR Intens

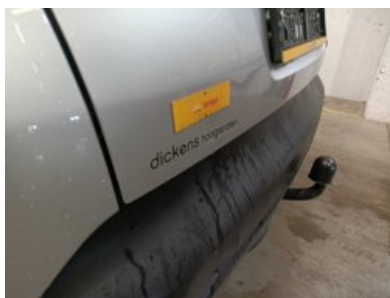
- ✓ **1. Rear:** Trunk - Visual Damage

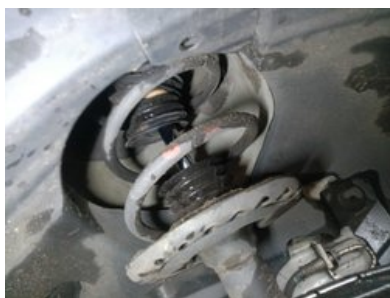
- ✓ **1. OTHER:** Engine Oil & Filter Change
- ✓ **2. SUSPENSION:** Strut Assembly (Both)

- ✓ 1. Anti-Roll Bar Link - Outer
- ✓ 2. Engine Oil & Filter Change
