# Diagnosis report of 2019 KIA SPORTAGE Dynamic Line

# Preparation and repair report of 2019 KIA SPORTAGE Dynamic Line

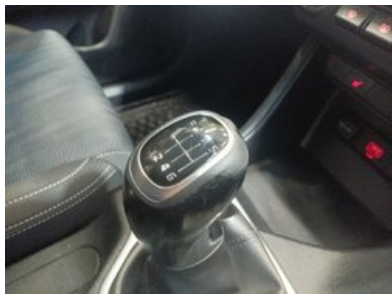
- ✔ 1. Inside: Gear Shift Boot and Gear Shift Knob - Condition

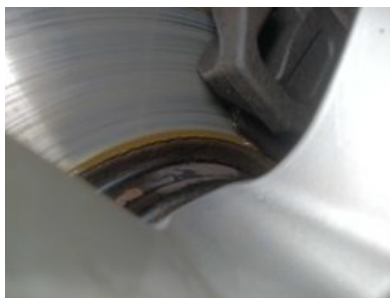
✓ **3. BRAKES:** Front Brake Pads (All)

- ✓ 1. Front Brake Pads (All)
- ✓ 2. Engine Oil & Filter Change
- ✓ 3. Charge Battery

- 1. Engine Oil 4.4L
- 2. Oil Filter (F026407308)
- 3. Brake Pads Kit (LP3535)
