# Diagnosis report of 2020 TOYOTA RAV 4 Premium Plus

## Diagnosis details

# Preparation and repair report of 2020 TOYOTA RAV 4 Premium Plus

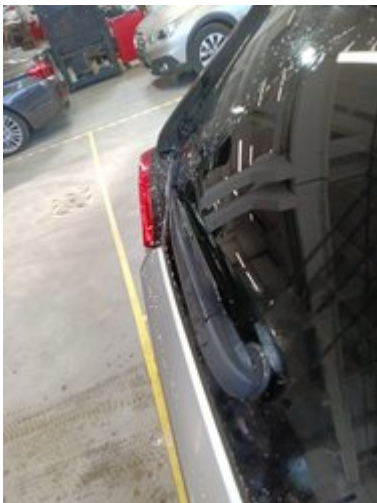
- ✔ **1. Front:** Window Wiper Rubber and Handle (Front and Rear) - Condition

- ✓ 1. Change Rear Wiper (Mechanical)
- ✓ 2. Engine Oil & Filter Change
- ✓ 3. Front Wheel Alignment (Toe)

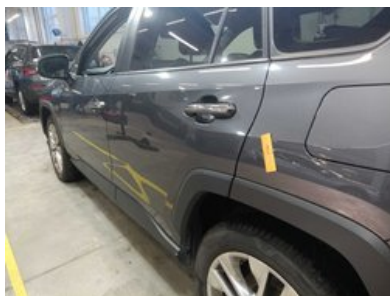
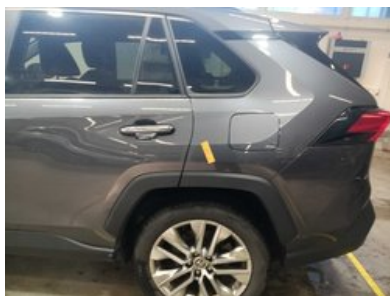
✔ **1. Side:** Left and Right Side - Visual Damage and Scratches

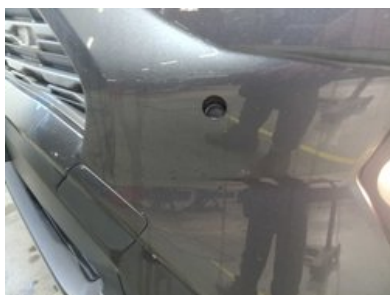
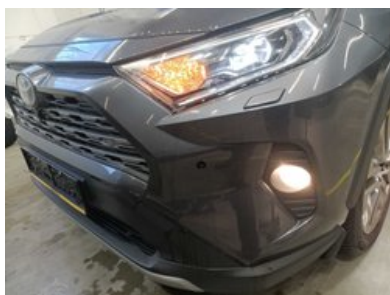
✔ **2. Front:** Front Bumper - Condition and Alignment

- ✓ 1. Paint Steering Wheel
- ✓ 2. Pushed In Parking Sensor

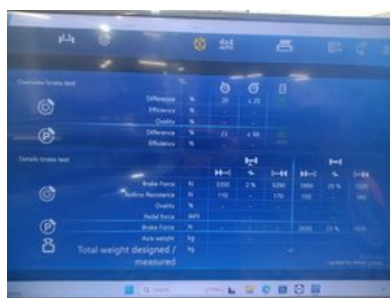
### ✓ 1. Brake Test Line Results

Vehicle Test Report

| Test Description | Pass/Fail | Value |
| Brake Force | Pass | 1000 |
| Brake Response | Pass | 100 |
| Brake Lock | Pass | 100 |
| Brake Release | Pass | 100 |

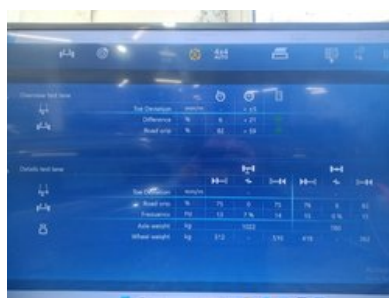
Total weight designed / measured

Vehicle Test Report

| Test Description | Pass/Fail | Value |
| Brake Force | Pass | 1000 |
