Diagnosis report of
2016 PEUGEOT 308 Premium

Preparation and repair report of
2016 PEUGEOT 308 Premium

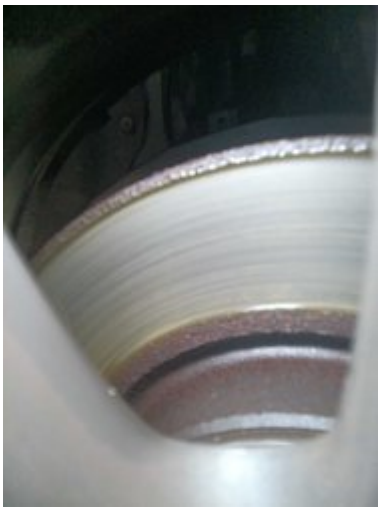
1. BRAKES: Rear Brake Disc (Both)

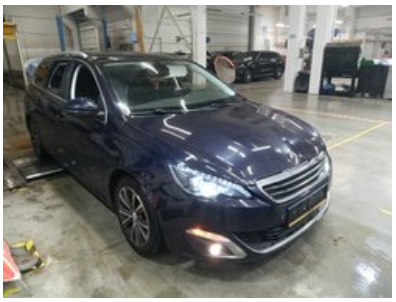
9. OTHER: Engine Camshaft Repair "Sandwich"

- 1. Front Brake Discs (Both) — Including Pads
- 2. Engine Oil & Filter Change
- 3. Suspension Lower Arm, Rear (Both)
- 4. Injectors (All)
- 5. Auxiliary Drive Belt
- 6. Anti-Roll Bar Link - Outer (Both)
- 7. Camshaft Drive Belt
- 8. Engine Camshaft Repair "Sandwich"
