Diagnosis report of
2020 VOLVO S60 R-Design

Preparation and repair report of
2020 VOLVO S60 R-Design

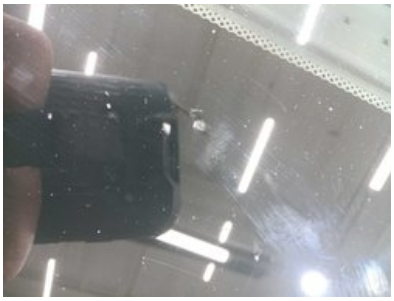
1. Front: Front Bumper - Condition and Alignment

2. Front: Windscreen Integrity - Free from MOT-Excluding Damage

3. Rear: Rear Bumper - Condition and Alignment

1. Windshield Replacement

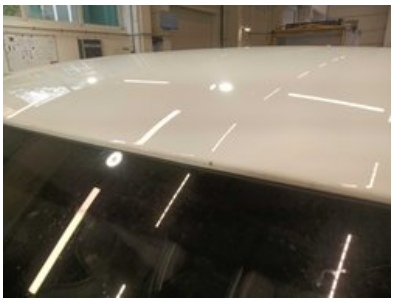
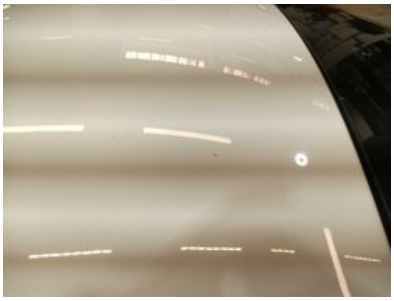
4. Other: Roof - Visual Damage (e.g., Hail Damage)

5. Other: Additional Polishing Tasks

6. Side: Left and Right Side - Visual Damage and Scratches

7. Side: Left and Right Side - Visual Damage and Scratches

8. Side: Left and Right Side - Visual Damage and Scratches
