Diagnosis report of
2018 RENAULT ESPACE Intens

Preparation and repair report of
2018 RENAULT ESPACE Intens

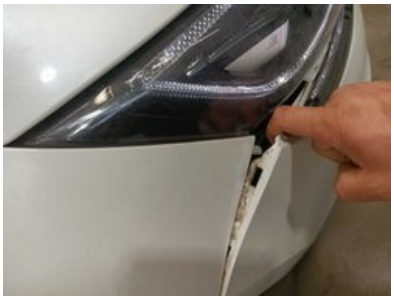
1. Front: Front Bumper - Condition and Alignment

- 1. Front Bumper Corner Repair
- 2. Change Window Lifter Button(s)
