Diagnosis report of
2016 OPEL CORSA

Diagnosis details

Preparation and repair report of
2016 OPEL CORSA

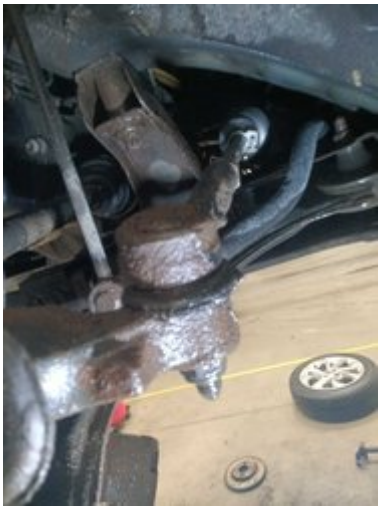
5. SUSPENSION: Anti-Roll Bar Link, Outer, Both Sides

6. BRAKES: Front Brake Discs Both with Pads

- 1. Shock Absorbers (Pair)
- 2. Track Rod End Joint (Both)
- 3. Front Brake Discs (Both) — Including Pads
- 4. Anti-Roll Bar Link - Outer (Both)
- 5. Front Wheel Alignment (Toe)
