Diagnosis report of
2016 VOLKSWAGEN GOLF 7 Connected S

Preparation and repair report of
2016 VOLKSWAGEN GOLF 7 Connected S

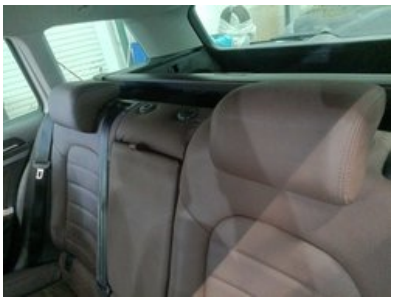
Interior

1. Seats: All Seats - Condition

2. Inside: Carpets - Condition

3. Inside: Trims - Condition

4. Front: Trims - Condition

5. Front: Steering Wheel - Condition

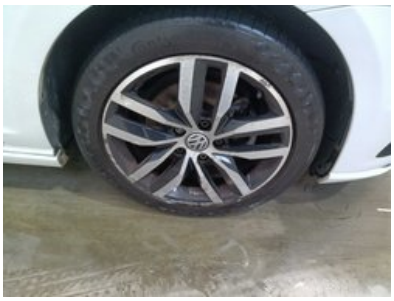
Exterior

1. Front: Windscreen Integrity - Free from MOT-Excluding Damage

2. Side: Wheels - Condition

- 1. Windshield Replacement
- 2. Change Ceiling Panel

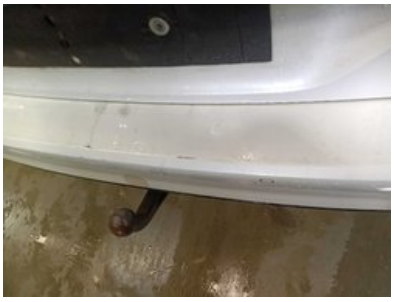
3. Rear: Rear Bumper - Condition and Alignment
