Diagnosis report of
2015 VOLVO V60 Momentum

Preparation and repair report of
2015 VOLVO V60 Momentum

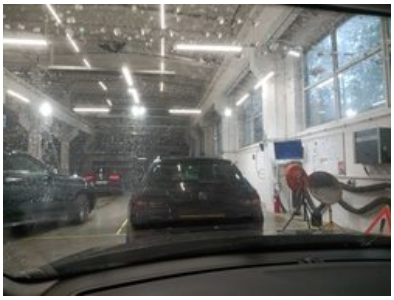
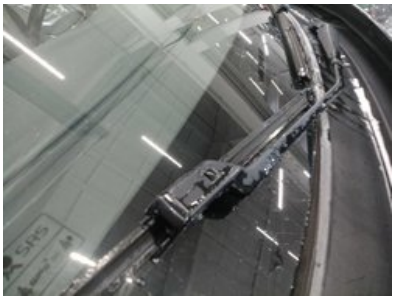
1. Front: Window Wiper Rubber and Handle (Front and Rear) - Condition
