Diagnosis report of
2020 SKODA OCTAVIA Sport Business

Preparation and repair report of
2020 SKODA OCTAVIA Sport Business

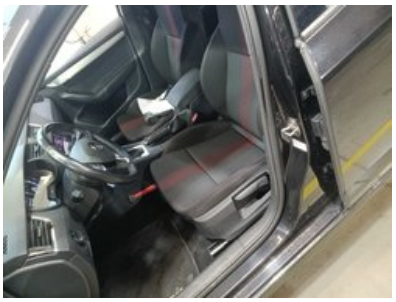
1. Inside: Interior Lighting - Basic Functioning and Damage

2. Inside: Gear Shift Boot and Gear Shift Knob - Condition

3. Inside: Trims - Condition

4. Inside: Trims - Condition

5. Inside: Accessories - Functioning and Condition

6. Seats: All Seats - Condition

7. Doors: Door Rubber Seals

- 1. Change Door Rubber Seal

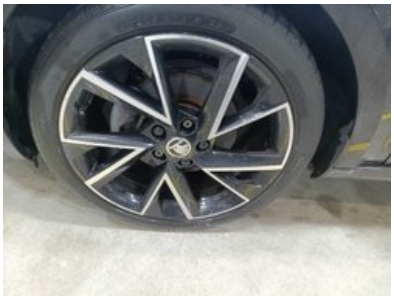
Exterior

1. Side: Wheels - Condition

2. Front: Front Bumper - Condition and Alignment
