Diagnosis report of
2016 AUDI A4 Design Pro Line Plus

Diagnosis details

Preparation and repair report of
2016 AUDI A4 Design Pro Line Plus

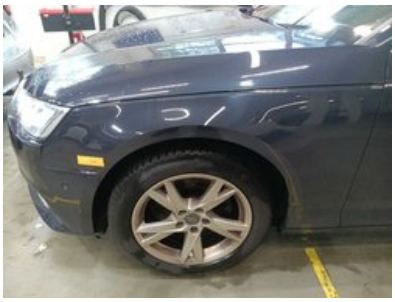
3. Side: Left and Right Side - Visual Damage and Scratches

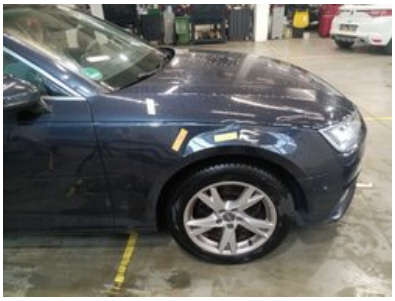
4. Side: Left and Right Side - Visual Damage and Scratches

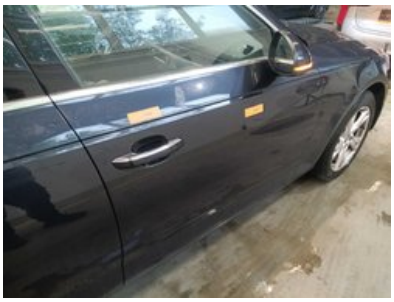
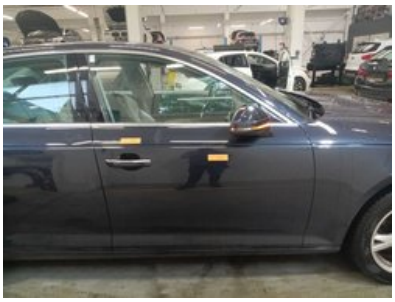
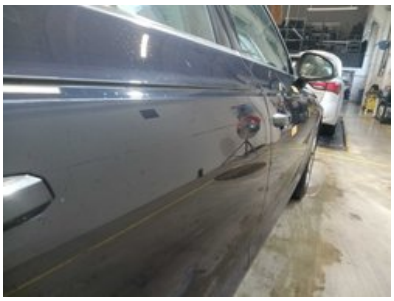
5. Side: Left and Right Side - Visual Damage and Scratches

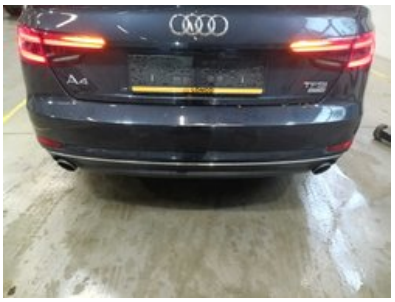
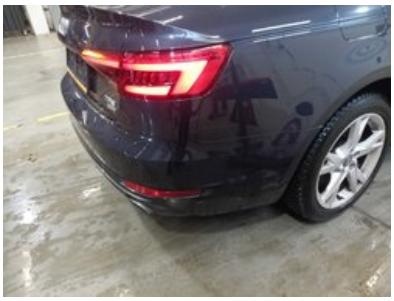
7. Rear: Rear Bumper - Condition and Alignment

- 1. Paint Front Fender
- 2. Paint Rear Bumper
- 3. Paint Hood

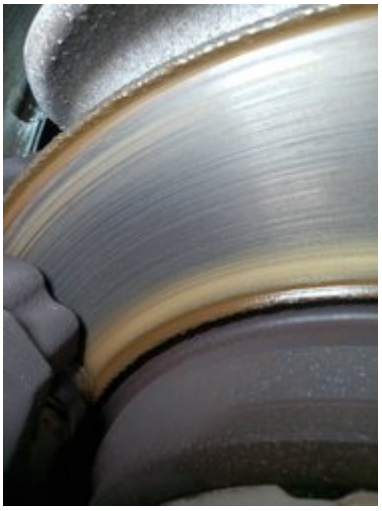
2. BRAKES: Rear Brake Disc (Both)
