Diagnosis report of
2018 AUDI A6 S Line Edition

Preparation and repair report of
2018 AUDI A6 S Line Edition

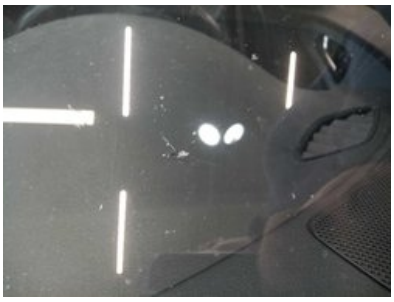
1. Lights: Front Lights (City, Regular, Full Headlight, Fog, Indicator) - Basic Functioning, Damage, and Color

- 1. Windshield Repair
- 2. Repair Front Lights (External)
- 3. Headlamp Alignment

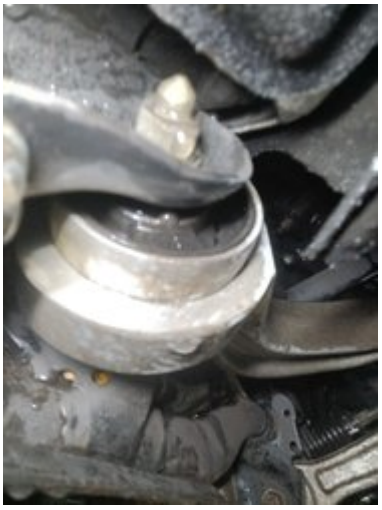
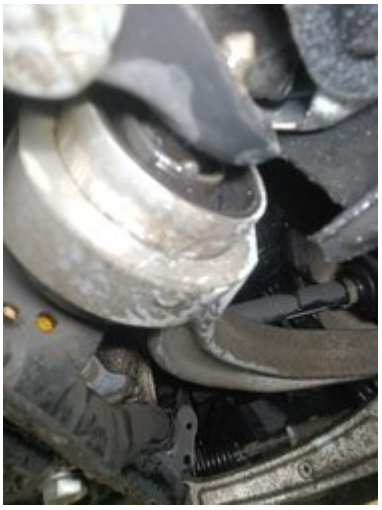
1. SUSPENSION: Suspension Lower Arm Bushes Both

2. COOLING SYSTEM: Header/Expansion Tank Hose

3. COOLING SYSTEM: Cooling Pipes

- 1. Suspension Lower Arm Bushes (Both)
- 2. Change Tires
- 3. Header/Expansion Tank Hose
- 4. Cooling Pipes
