Diagnosis report of
2018 AUDI Q5 Sport

Preparation and repair report of
2018 AUDI Q5 Sport

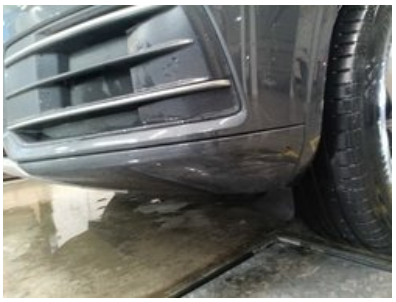
1. Other: Additional Polishing Tasks

2. Front: Hood Sound Insulation - Condition

3. Front: Front Bumper - Condition and Alignment

4. Rear: Rear Bumper - Condition and Alignment

- 1. Paint Front Bumper
- 2. Paint Rear Bumper
- 3. Paint Door

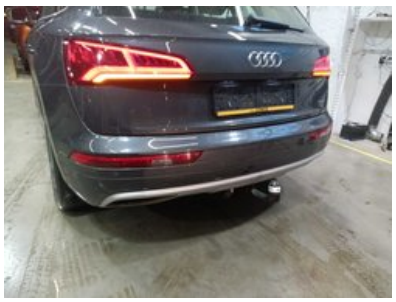
5. Lights: Light Bulbs

6. Lights: Rear Lights (Brake, Fog, Indicator) - Basic Functioning, Damage, and Color

7. Side: Left and Right Side - Visual Damage and Scratches

8. Side: Left and Right Side - Visual Damage and Scratches

- 1. Change Rear Lights
- 2. Headlamp Alignment

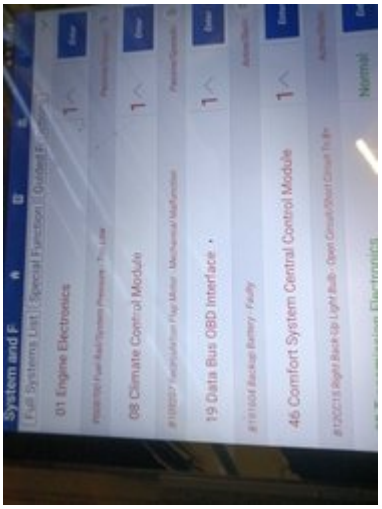
3. BRAKES: Rear Brake Disc (Both) - Brake Pads Removed

4. SUSPENSION: Shock Absorber Dust Cover Both Sides

5. GENERAL ELECTRICS: Battery

- 1. Engine Oil & Filter Change
- 2. Charge Battery
- 3. Battery
