Diagnosis report of
2019 KIA SPORTAGE GT Line

Summary of diagnosed issues

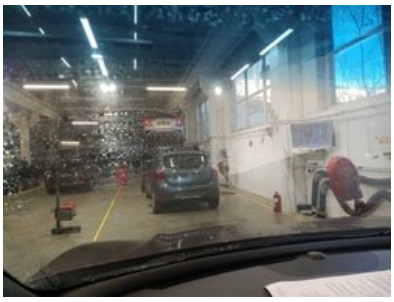
Interior

1. Front: Steering Wheel - Condition

2. Front: Sun Visors - Operation and Condition

3. Front: Window Wiper Rubber and Handle (Front and Rear) - Condition

4. Inside: Trims - Condition

- 1. Paint Steering Wheel
- 2. Electronic Parking Brake Button
- 3. Change Sun Visor

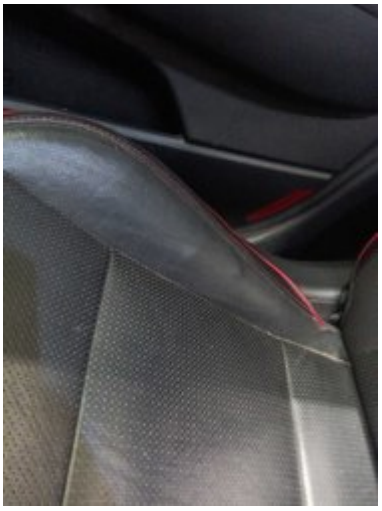
5. Seats: All Seats - Condition

6. Doors: Door Rubber Seals
