Diagnosis report of
2016 LEXUS RX 450H Luxury Line

Diagnosis details

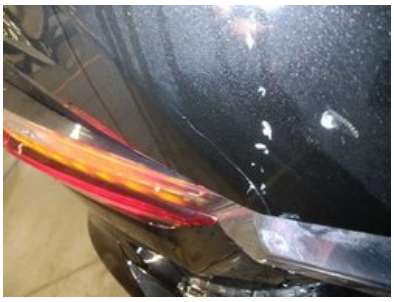
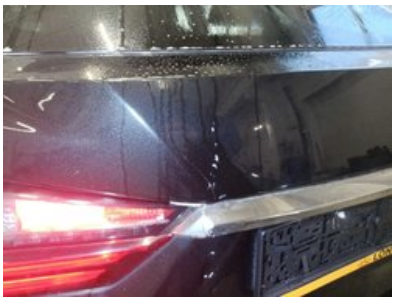
1. Rear: Rear Bumper - Condition and Alignment

2. Rear: Trunk - Visual Damage

3. Rear: Trunk - Visual Damage

1. Paint Boot
2. Paint Rear Bumper
