Diagnosis report of
2017 RENAULT ESPACE Initiale Paris

Preparation and repair report of
2017 RENAULT ESPACE Initiale Paris

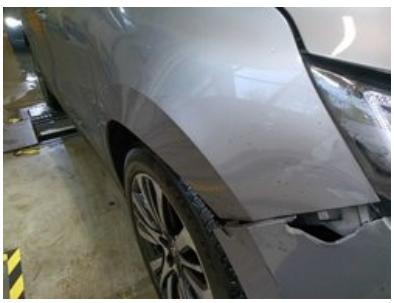
1. Front: Front Bumper - Condition and Alignment
