Diagnosis report of
2021 SKODA KAROQ Business Edition Pl

Diagnosis details

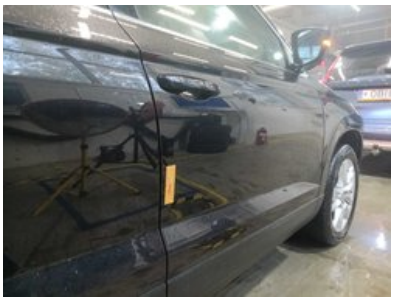
1. Side: Left and Right Side - Visual Damage and Scratches

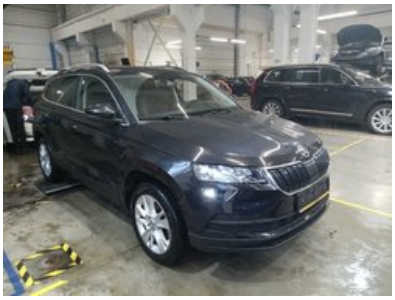
2. OTHER: Change Tires

- 1. Engine Oil & Filter Change
- 2. EVAP
- 3. Change Tires

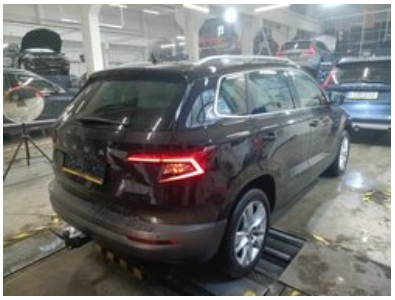
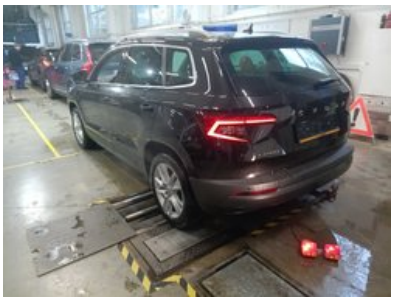
3. ENGINE: EVAP
