Diagnosis report of
2015 FORD MONDEO Titanium

Diagnosis details

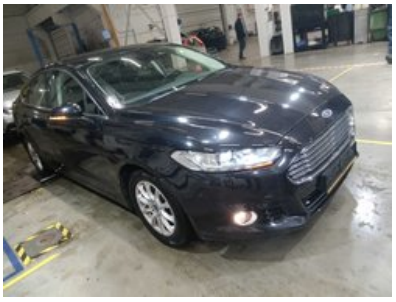
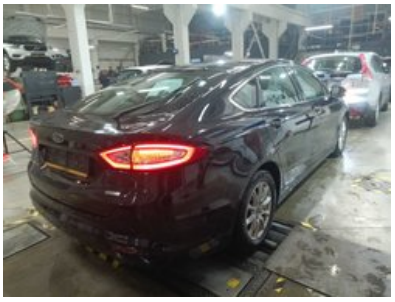
2. BRAKES: Front Brake Discs Both with Pads

- 1. Engine Oil & Filter Change
- 2. Front Brake Discs (Both) — Including Pads
- 3. Compressor

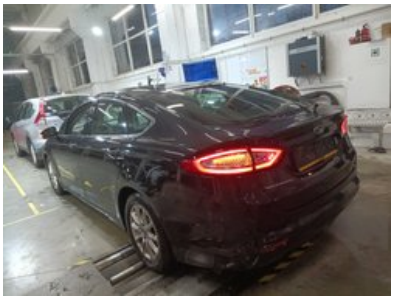
3. OTHER: Engine Oil & Filter Change
