Diagnosis report of

2011 RENAULT MEGANE Bose

Diagnosis details

Date of completion: 24.10.2024

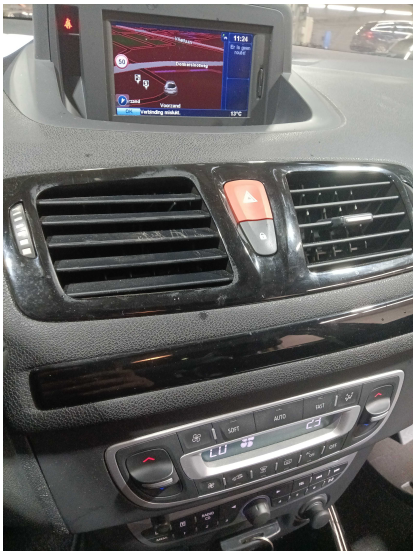
1. FRONT: Trims - condition

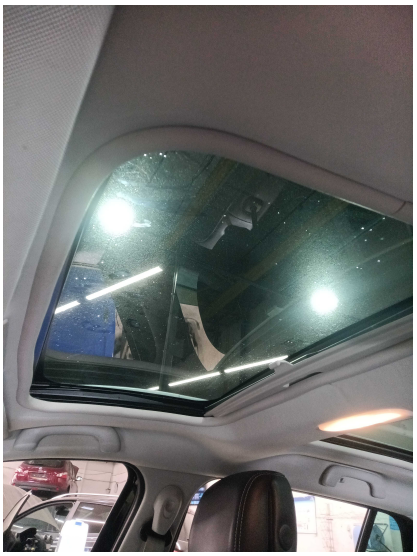
2. OPERATION: Roof items - electronic opening and condition

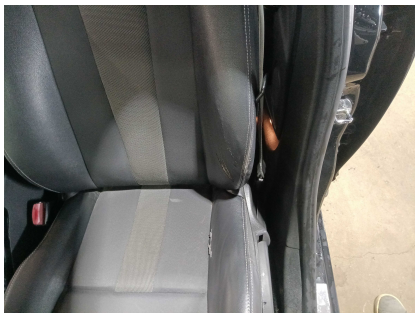
4. SEATS: All seats - condition

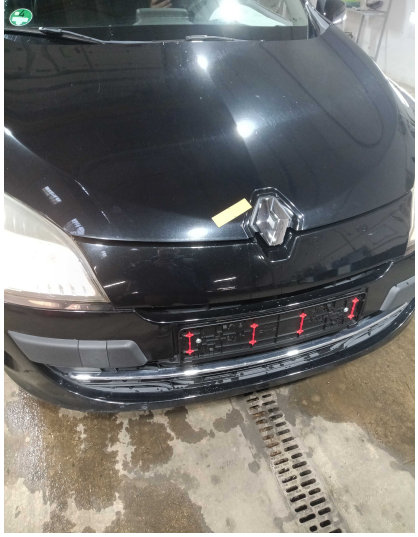
1. FRONT: Hood - visual damage
