# Diagnosis report of

## 2021 VOLKSWAGEN ID.3 Life

# Diagnosed issues repaired

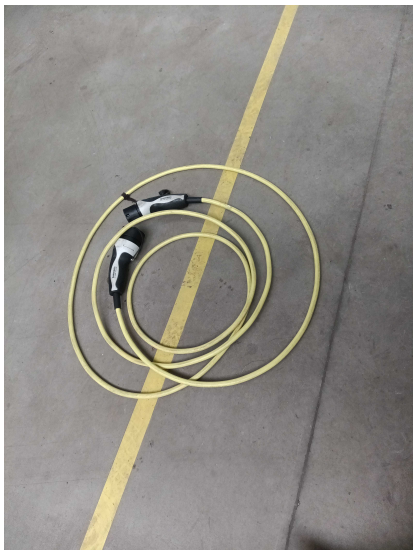
### 1. OTHER: Any other audible signs (ie. rambling of lose parts, etc)

✔ Charging cable

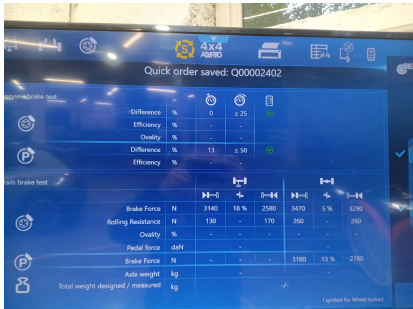
### 2. OTHER: Brake test line results

| | | M=1 | % | M=14 | % | M=14 | % |
|---|---|---|---|---|---|---|---|
| Brake Force | N | 3140 | 100% | 2580 | 3470 | 5% | 3200 |
| Rolling Resistance | N | 130 | - | 130 | 260 | - | 260 |
| Brake Force | N | - | - | - | 3180 | 13% | 2780 |

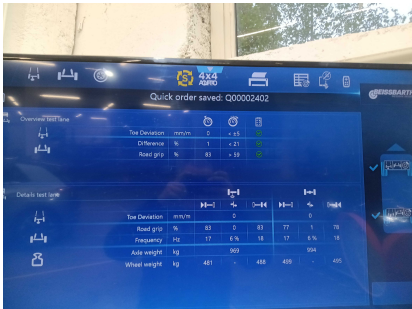
| | | M=1 | % | M=14 | % | M=14 | % |
|---|---|---|---|---|---|---|---|
| Toe Deviation | mm/m | 0 | - | 4 | ±5 | - | - |
| Efficiency | % | 1 | - | 2 | ±2 | - | - |
| Road grip | % | 83 | - | 83 | ±10 | - | - |

| | | M=1 | % | M=14 | % | M=14 | % |
|---|---|---|---|---|---|---|---|
| Toe Deviation | mm/m | 0 | - | 0 | - | 0 | - |
| Road grip | % | 83 | 0 | 83 | 77 | 1 | 7% |
| Frequency | Hz | 17 | 6.5 | 18 | 17 | 8% | 18 |
| Auto weight | kg | 909 | - | - | - | - | - |
| Wheel weight | kg | 481 | - | 418 | 459 | - | 405 |
